Title: Impact resistance testing of the Barracuda brick slip system

Report No: N950-22-18403

**Customer:** James & Taylor Ltd,  
Sixty-Two, Barwell Business Park,  
Leatherhead Road, Chessington, Surrey KT9 2NY.

**Issue date:** 7 February 2024

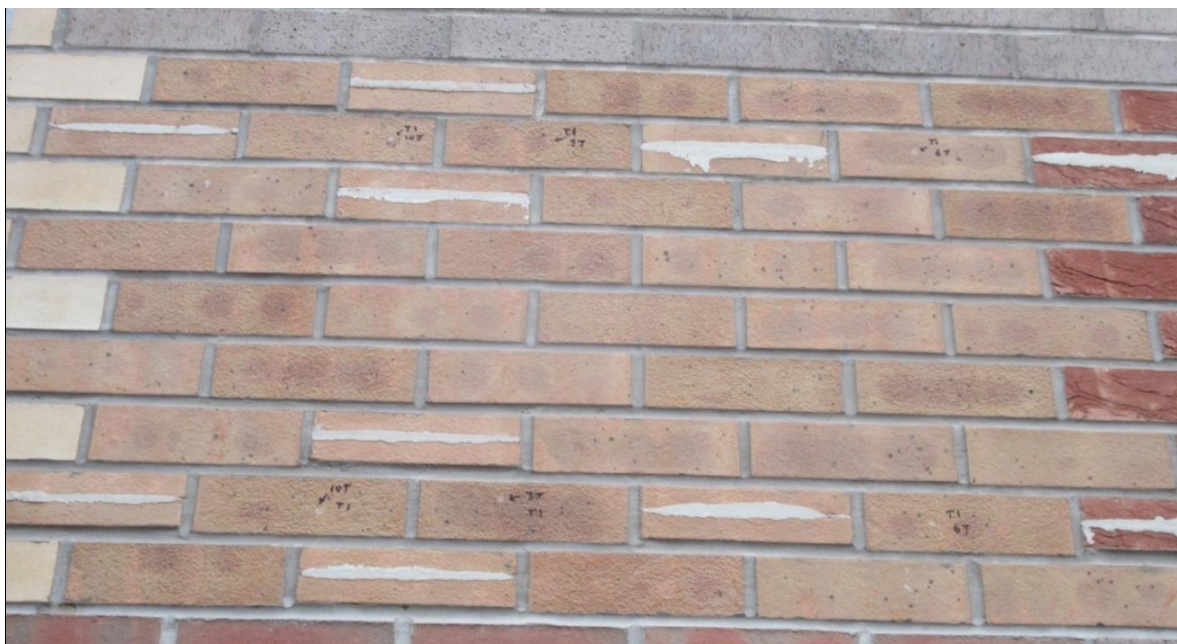
PHOTO 4016

| Location | Impact energy (J) | Observations | Classification |
|---|---|---|---|
| Upper left | 10 | Small mark | Class 1/Negligible risk |
| Lower left | 10 | Small mark | Class 1/Negligible risk |

BRICK TYPE 1 AFTER IMPACT TESTS

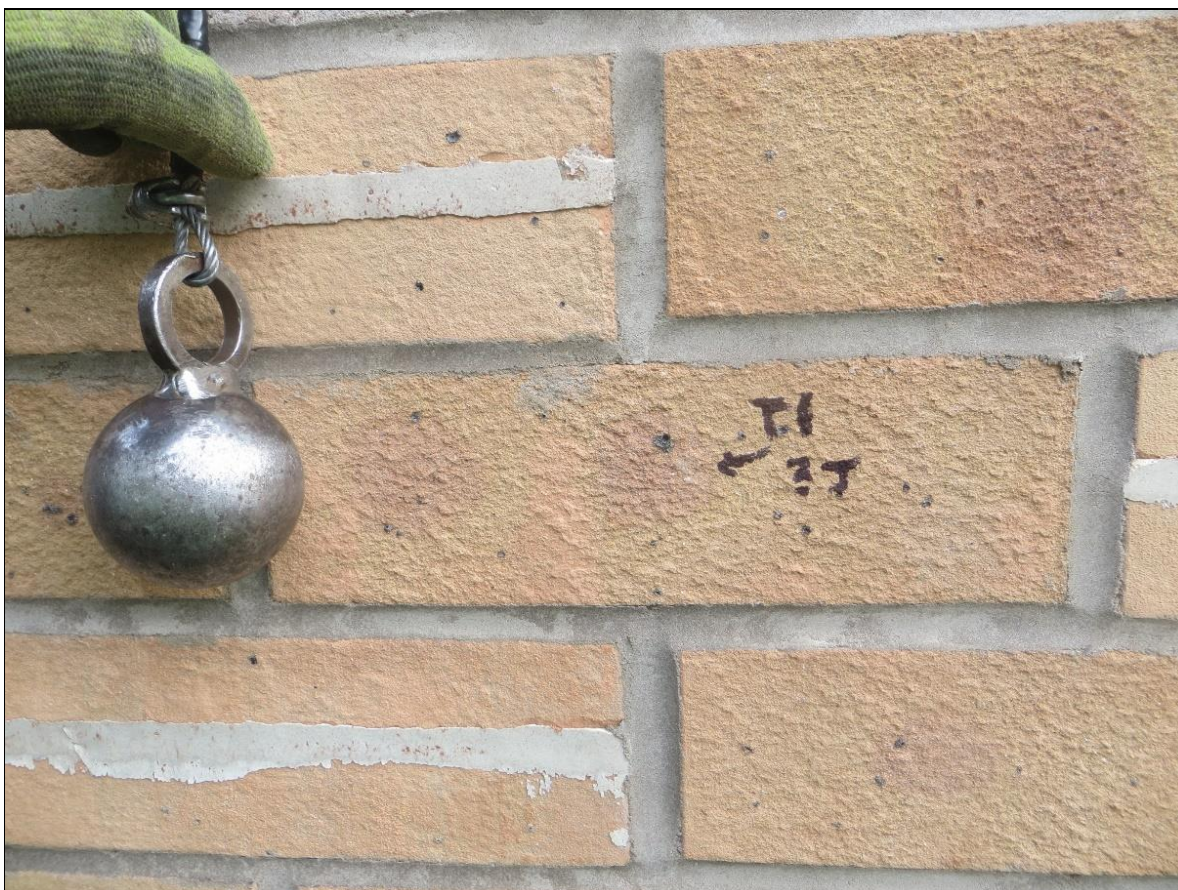
PHOTO 4047

| Location | Impact energy (J) | Observations | Classification |
|---|---|---|---|
| Upper centre | 3 | No visible damage | Class 1/Negligible risk |

3 J HARD BODY IMPACT

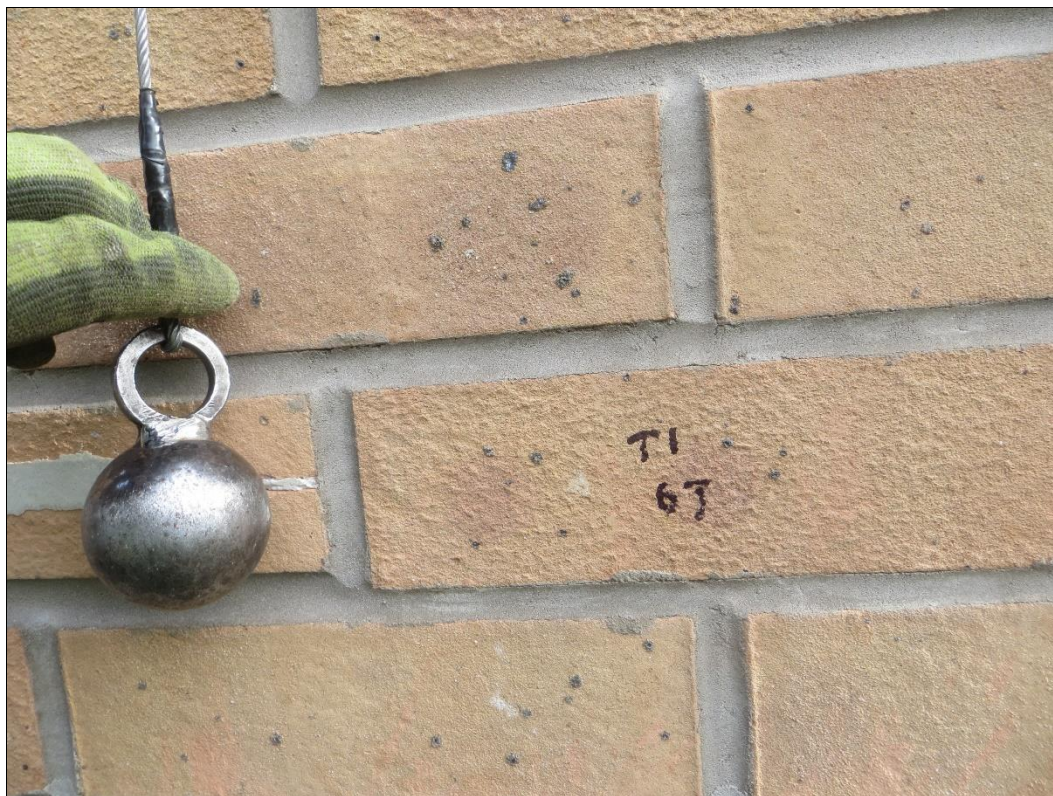
PHOTO 4045

| Location | Impact energy (J) | Observations | Classification |
|---|---|---|---|
| Upper right | 6 | Small mark | Class 1 |

6 J HARD BODY IMPACT

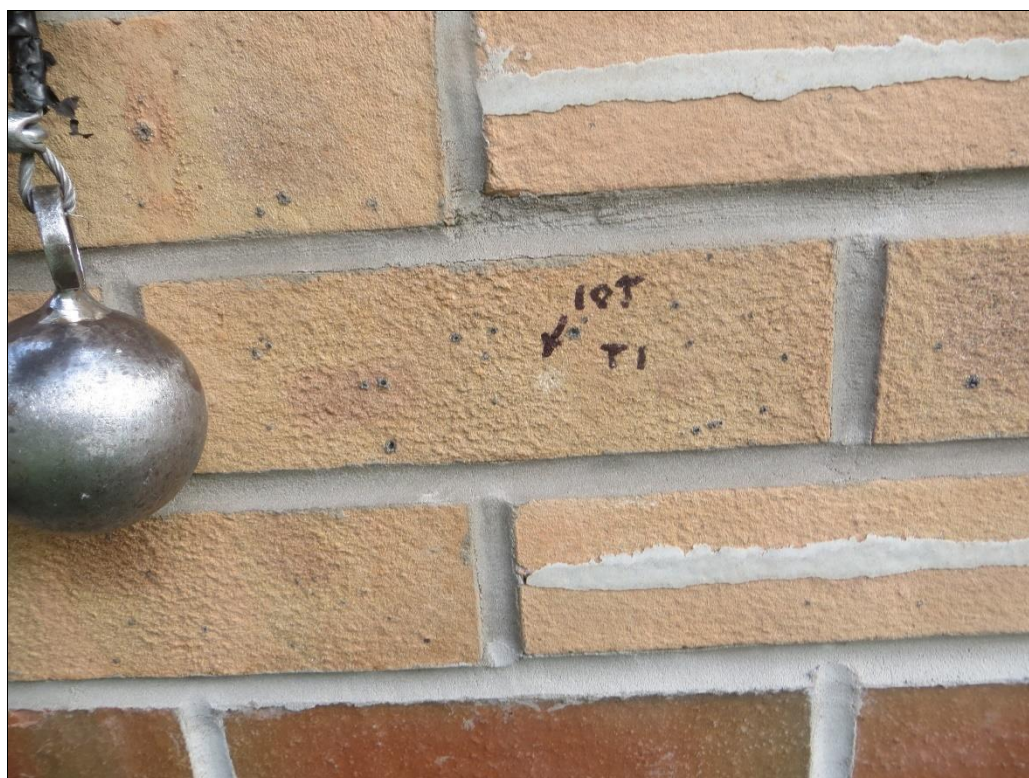
PHOTO 4056

10 J HARD BODY IMPACT

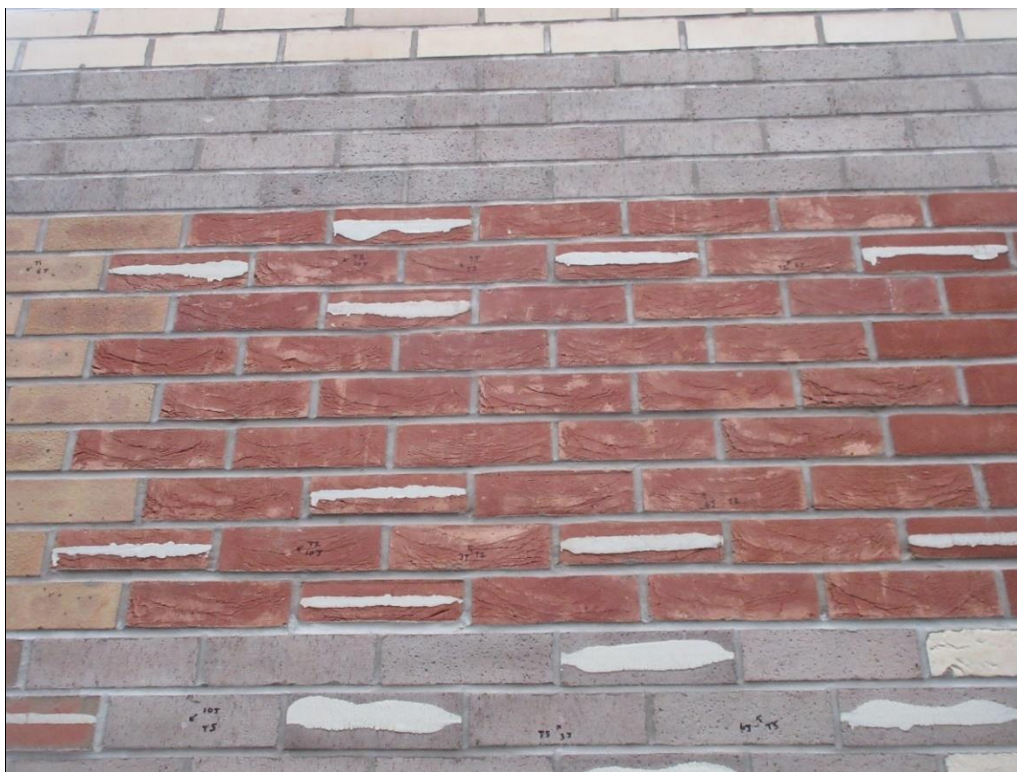
PHOTO 4057

BRICK TYPE 2 AFTER IMPACT TESTS

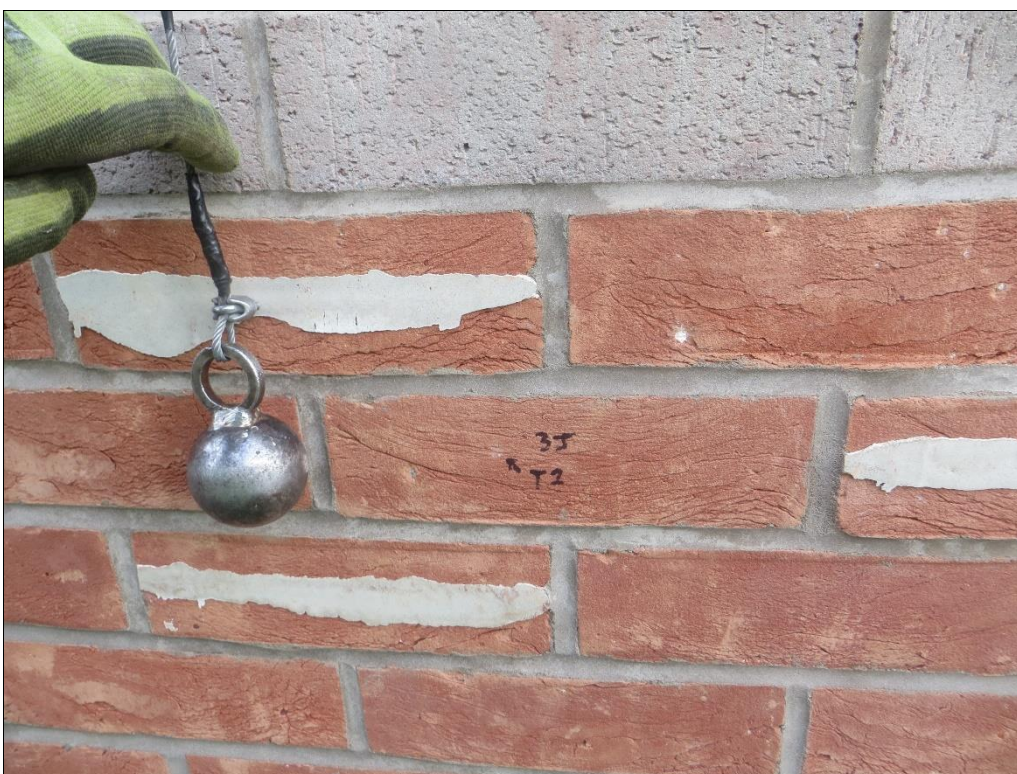
PHOTO 4036

| Location | Impact energy (J) | Observations | Classification |
|---|---|---|---|
| Upper centre | 3 | Small mark | Class 1/Negligible risk |

3 J HARD BODY IMPACT

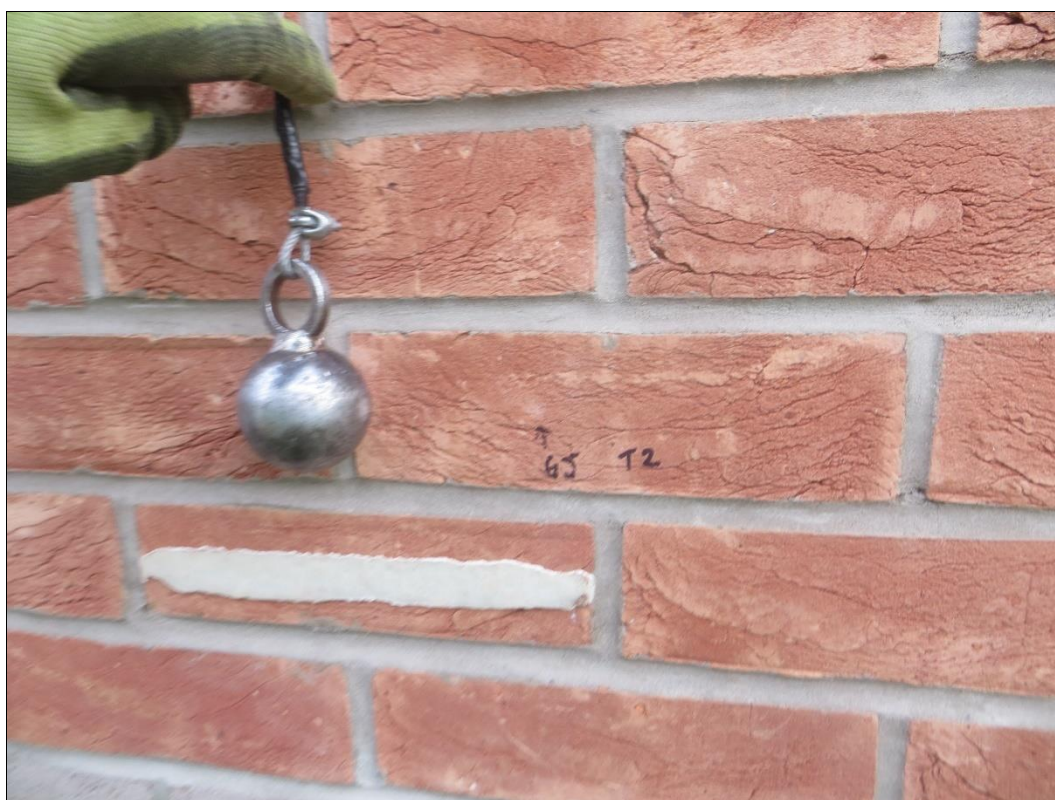
PHOTO 4034

| Location | Impact energy (J) | Observations | Classification |
|---|---|---|---|
| Upper right | 6 | Small mark | Class 1 |

6 J HARD BODY IMPACT

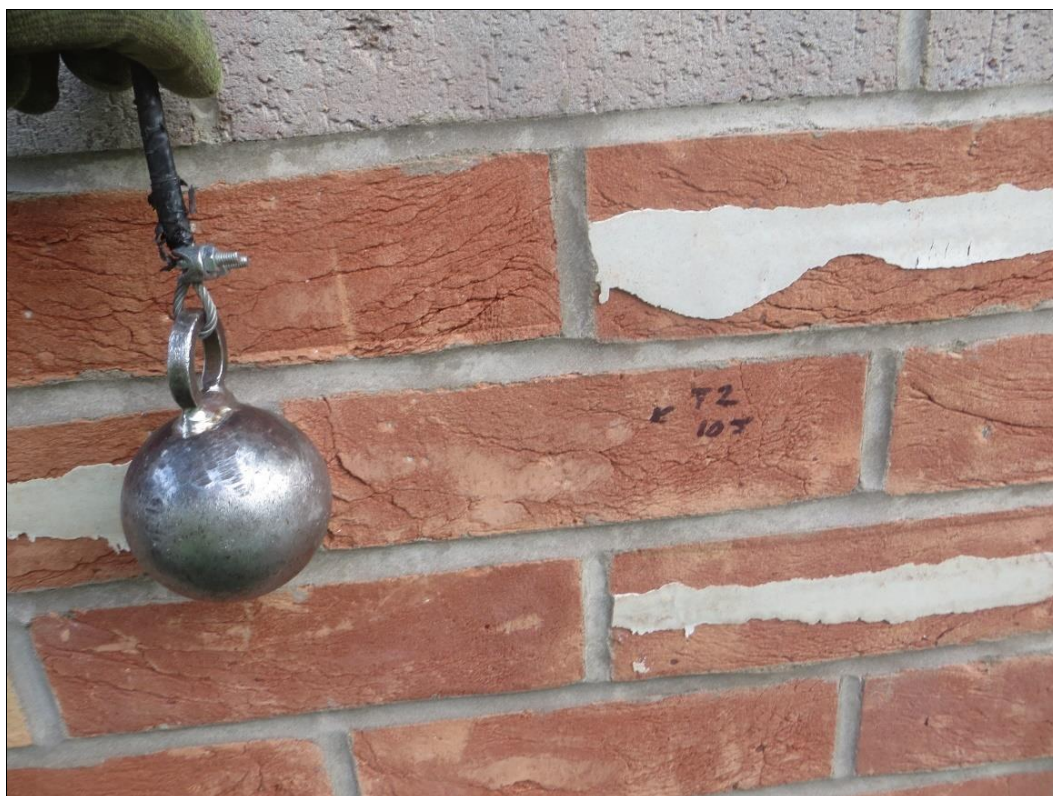
PHOTO 4058

| Location | Impact energy (J) | Observations | Classification |
|---|---|---|---|
| Upper left | 10 | Small mark | Class 1/Negligible risk |

10 J HARD BODY IMPACT

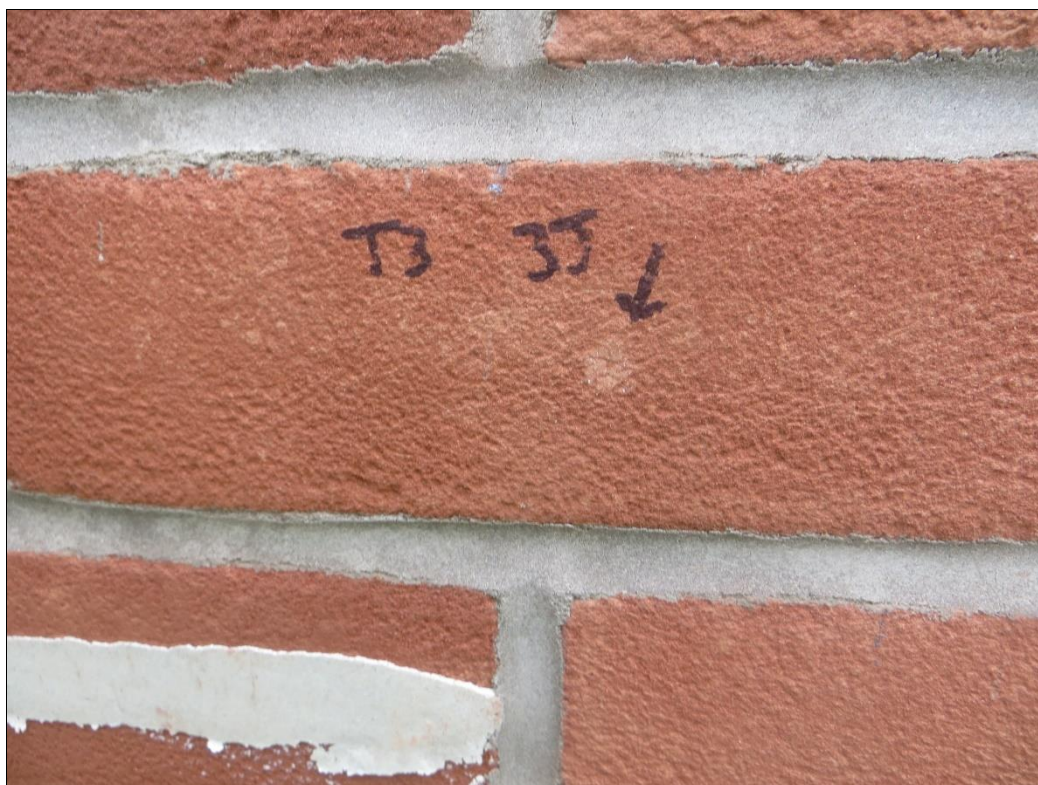
PHOTO 4025

| Location | Impact energy (J) | Observations | Classification |
|---|---|---|---|
| Upper centre | 3 | Small mark | Class 1/Negligible risk |

3 J HARD BODY IMPACT

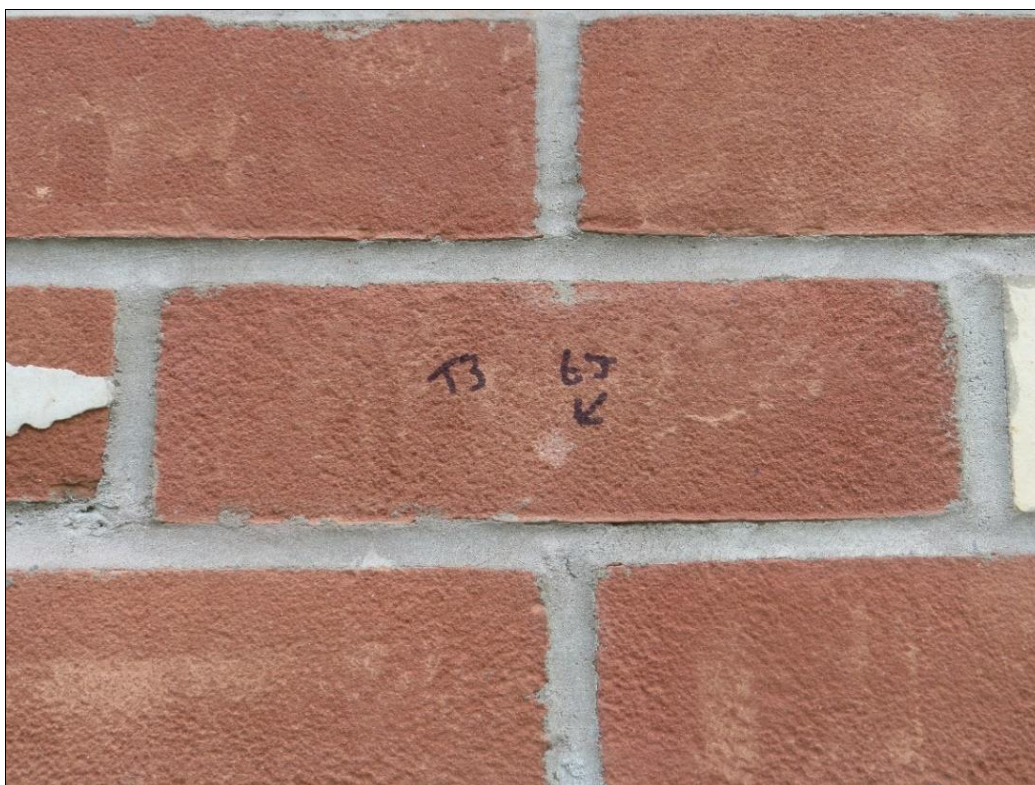
PHOTO 4023

| Location | Impact energy (J) | Observations | Classification |
|---|---|---|---|
| Upper right | 6 | Small mark | Class 1 |

6 J HARD BODY IMPACT

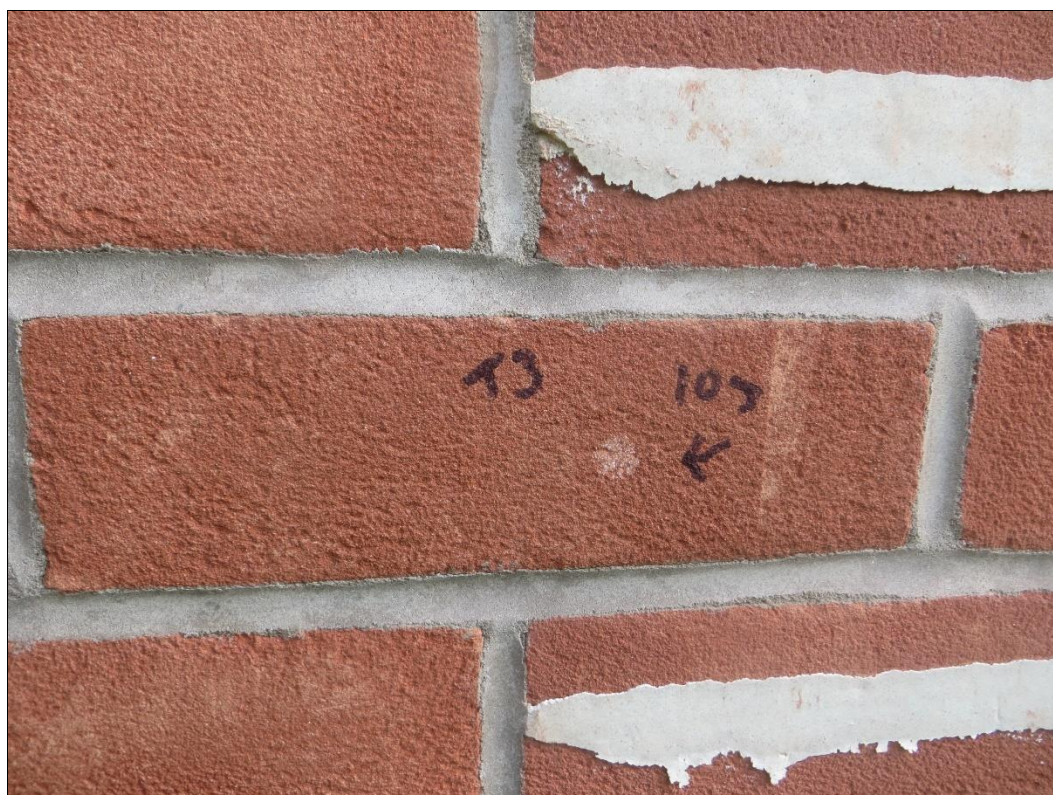
PHOTO 4066

| Location | Impact energy (J) | Observations | Classification |
|---|---|---|---|
| Upper left | 10 | Small mark | Class 1/Negligible risk |

10 J HARD BODY IMPACT

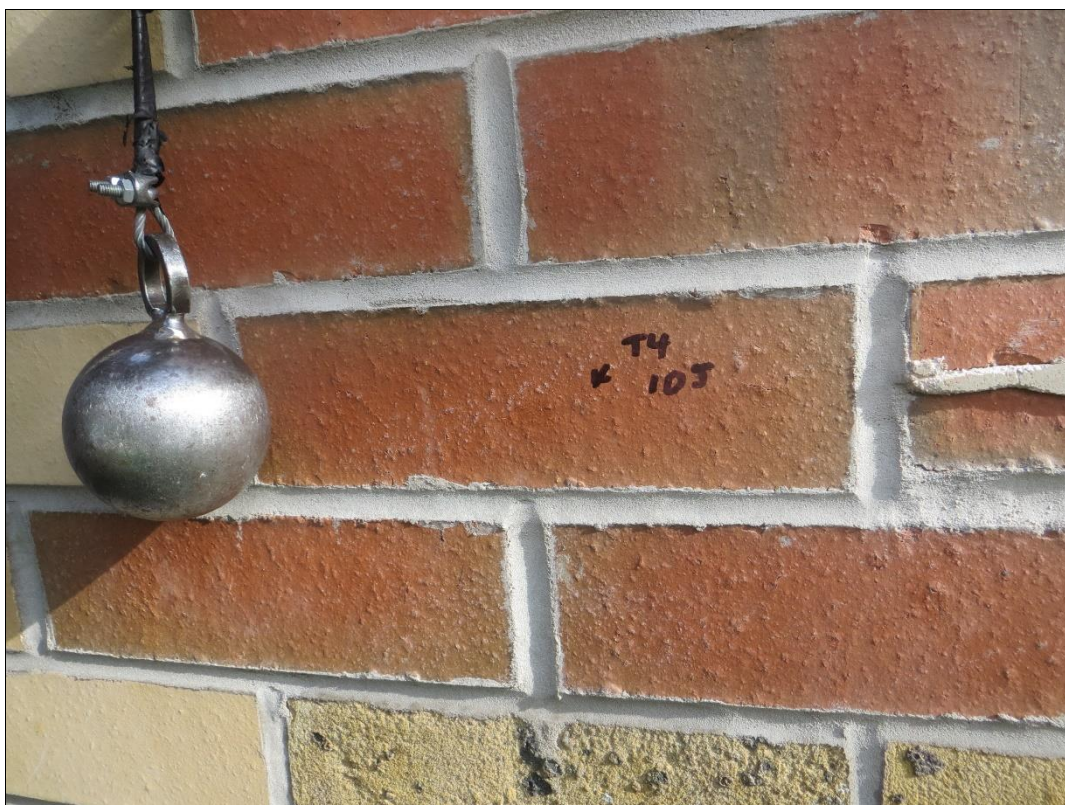
PHOTO 4054

| Location | Impact energy (J) | Observations | Classification |
|---|---|---|---|
| Upper left | 10 | Small mark | Class 1/Negligible risk |

10 J HARD BODY IMPACT

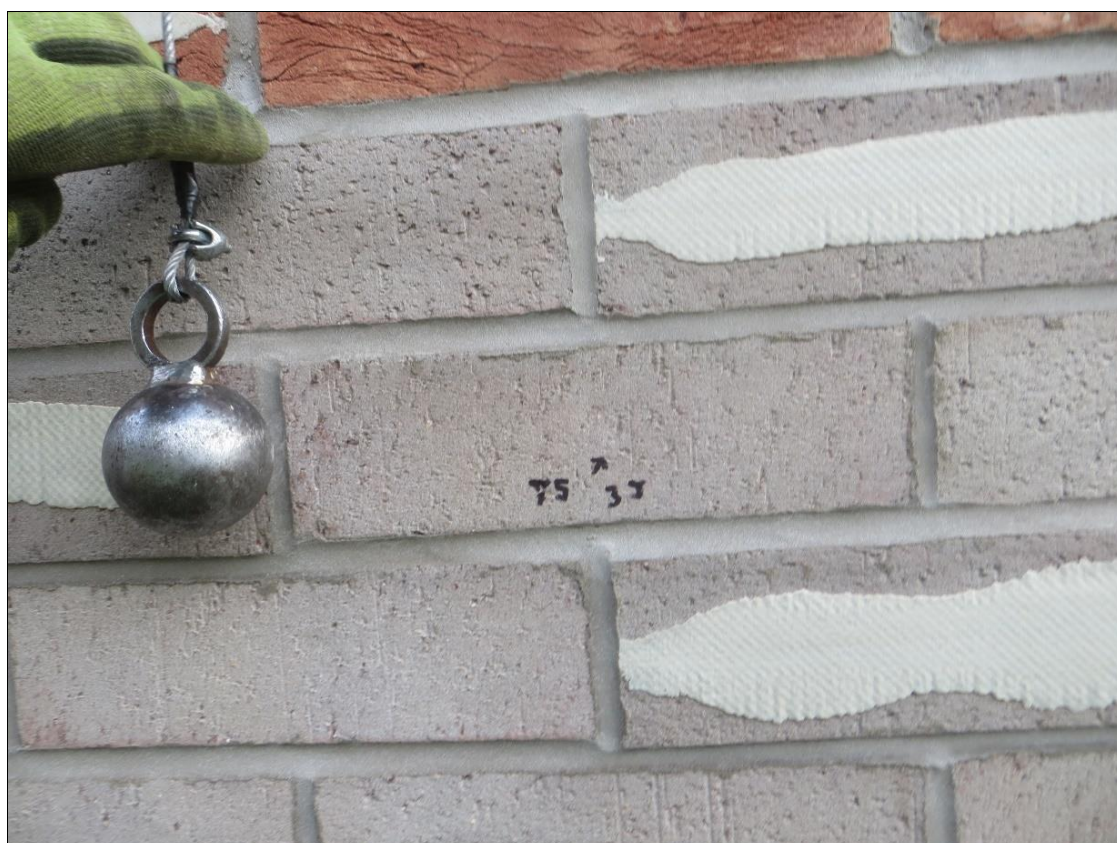
PHOTO 4038

| Location | Impact energy (J) | Observations | Classification |
|---|---|---|---|
| Upper centre | 3 | Small mark | Class 1/Negligible risk |

### 3 J HARD BODY IMPACT

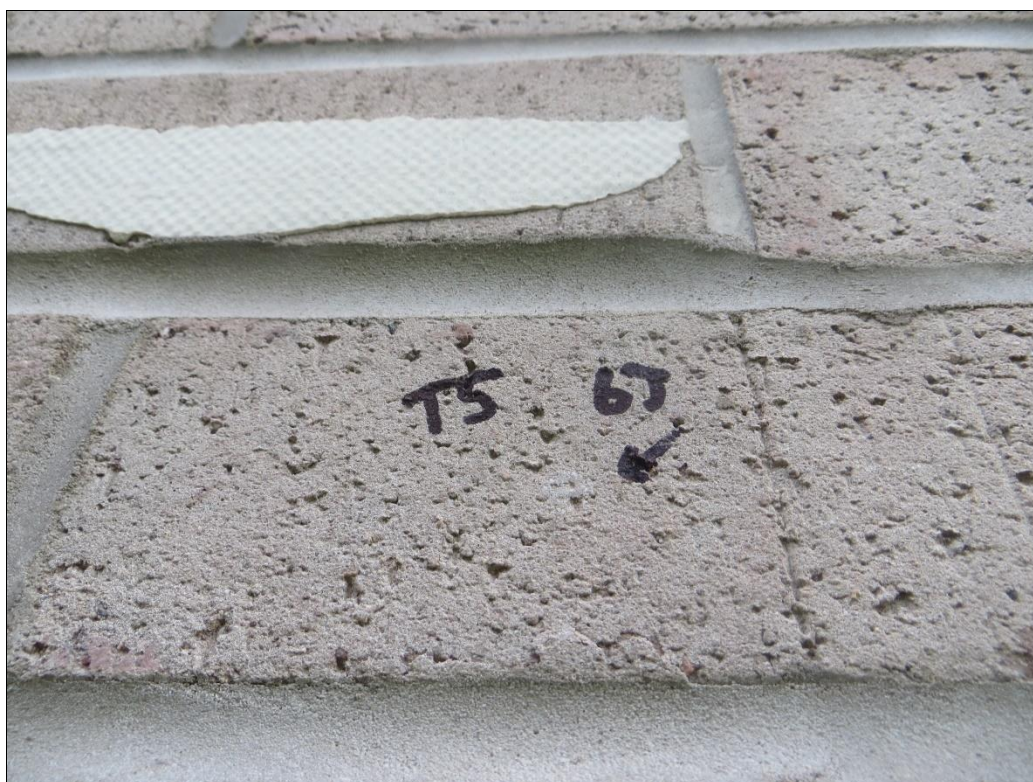
PHOTO 4032

| Location | Impact energy (J) | Observations | Classification |
|---|---|---|---|
| Upper right | 6 | Small mark | Class 1 |

6 J HARD BODY IMPACT

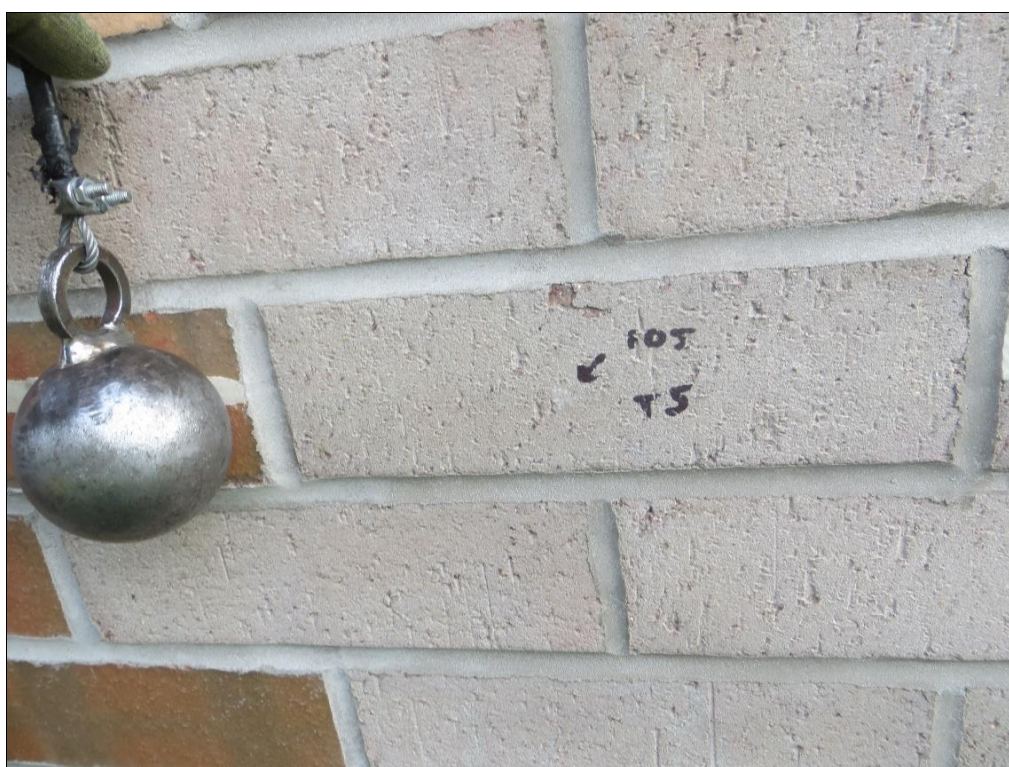
PHOTO 4060

| Location | Impact energy (J) | Observations | Classification |
|---|---|---|---|
| Upper left | 10 | Small chip | Class 1/Negligible risk |

10 J HARD BODY IMPACT
