Title: Heat Rain, Freeze Thaw, Cyclic Wind Loading and Impact Testing of Barracuda Brick Slip System.

Report No: N950-24-18683

**Customer:** James & Taylor Ltd,  
Sixty-Two, Barwell Business Park,  
Leatherhead Road, Chessington, Surrey KT9 2NY.

**Issue date:** 6 March 2024

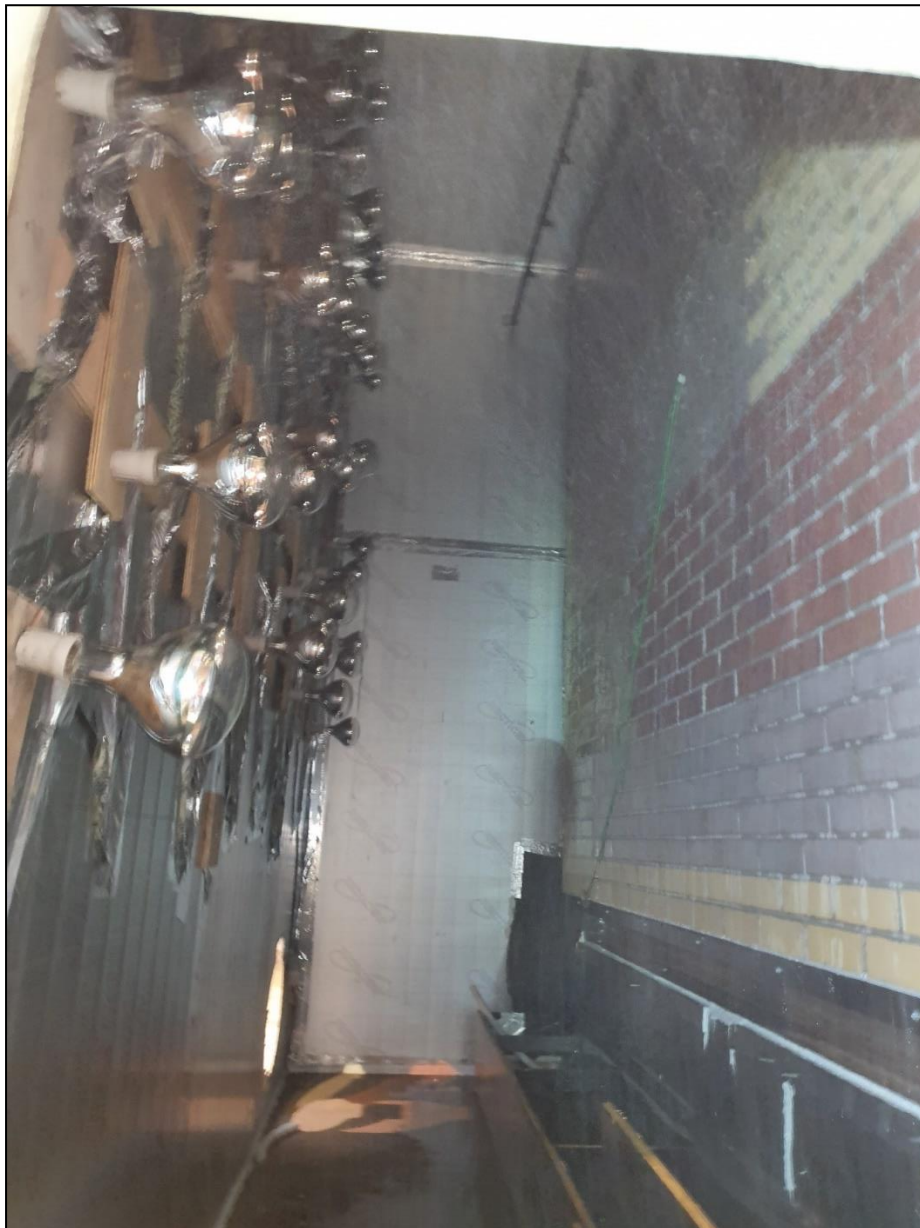
PHOTO 20221123\_132854

Hairline cracking  $<0.2$  mm was observed running horizontally through the mortar beds at several locations, up to a maximum length of 1.5 m.

TEST SETUP AND WATER SPRAYING OCCURING

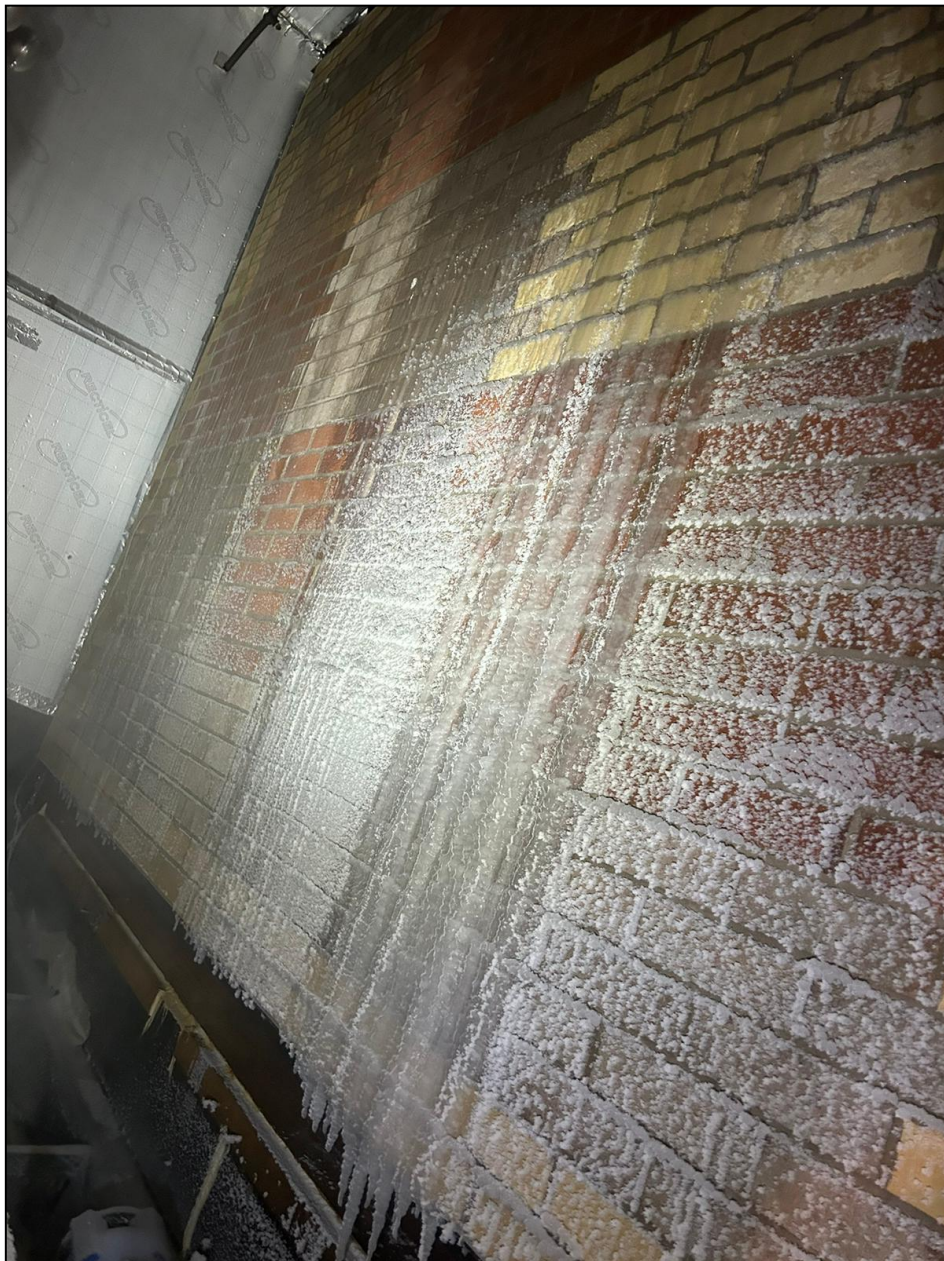
PHOTO IMG\_56422

Hairline cracking  $<0.2$  mm was observed running horizontally through the mortar beds at several locations, up to a maximum length of 1.5 m.

ICE BUILD UP ON FACE OF BRICKS SLIPS BEFORE THAWING

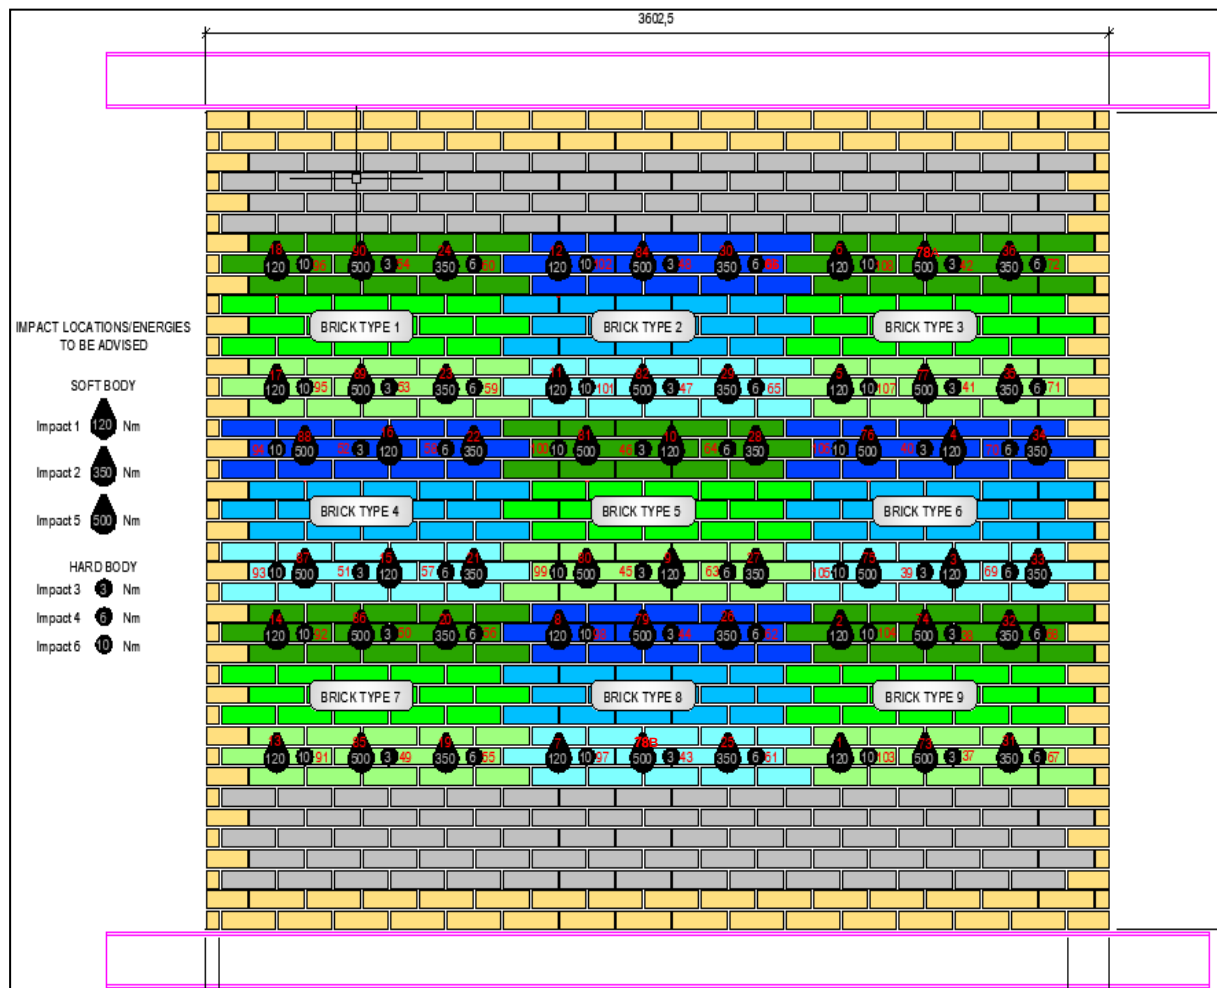
FIGURE 2

HARD BODY IMPACT LOCATIONS

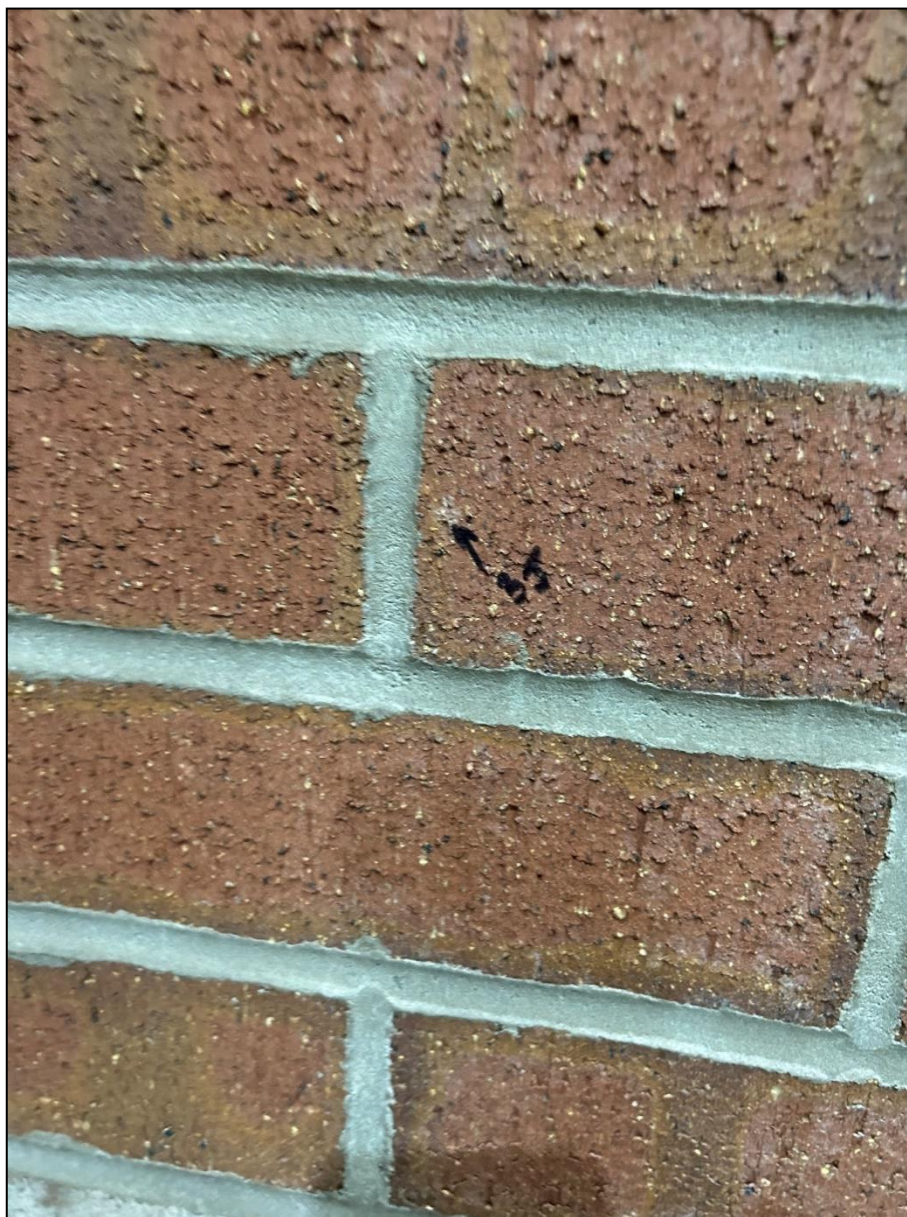
PHOTO IMG\_6156

| Location | Impact energy (J) | Observations | Classification |
|---|---|---|---|
| 37 | 3 | Small mark | Class 1<br>Negligible risk |

IMPACT LOCATION 37

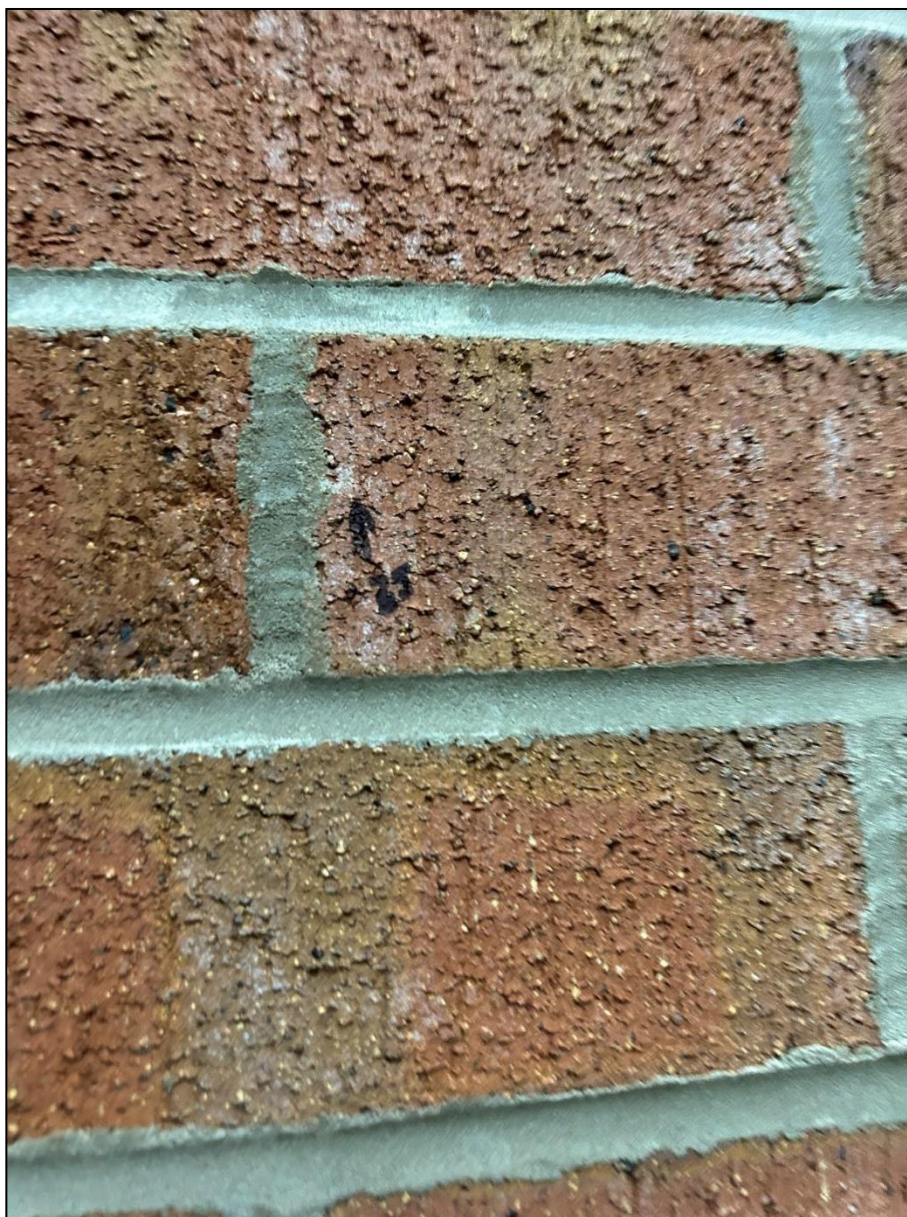
PHOTO IMG\_6157

| Location | Impact energy (J) | Observations | Classification |
|---|---|---|---|
| 38 | 3 | Small mark | Class 1<br>Negligible risk |

IMPACT LOCATION 38

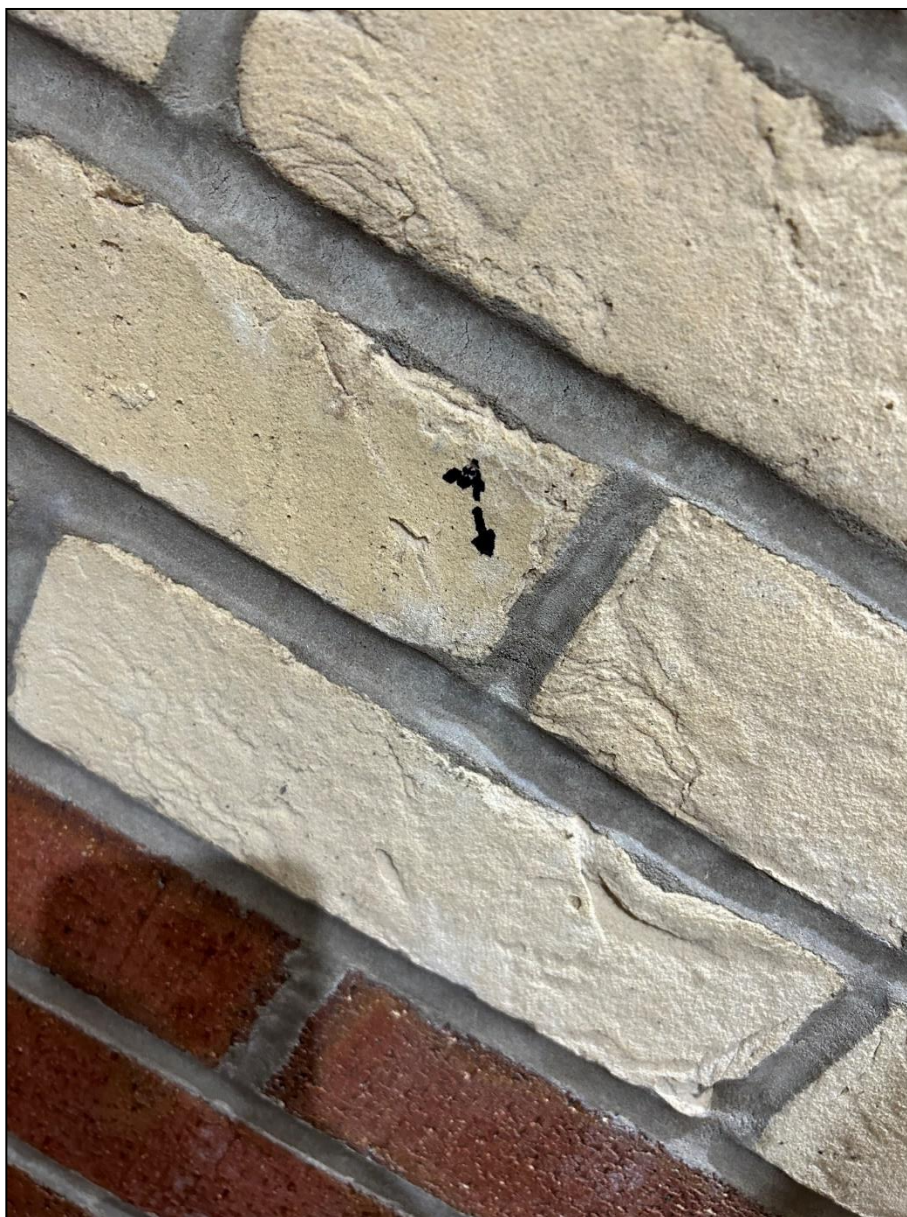
PHOTO IMG\_6158

| Location | Impact energy (J) | Observations | Classification |
|---|---|---|---|
| 39 | 3 | Small mark | Class 1<br>Negligible risk |

IMPACT LOCATION 39

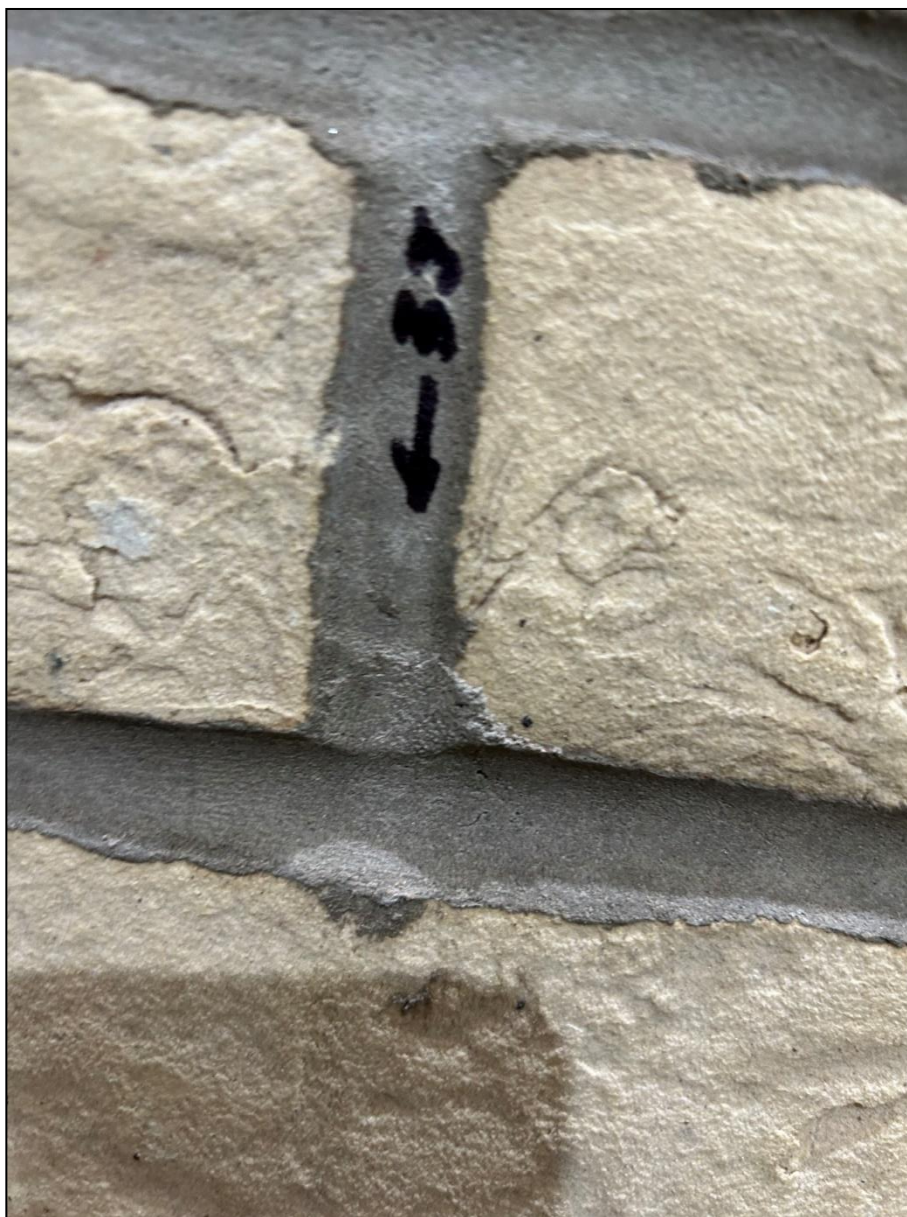
PHOTO IMG\_6159

| Location | Impact energy (J) | Observations | Classification |
|---|---|---|---|
| 40 | 3 | Small mark | Class 1<br>Negligible risk |

IMPACT LOCATION 40

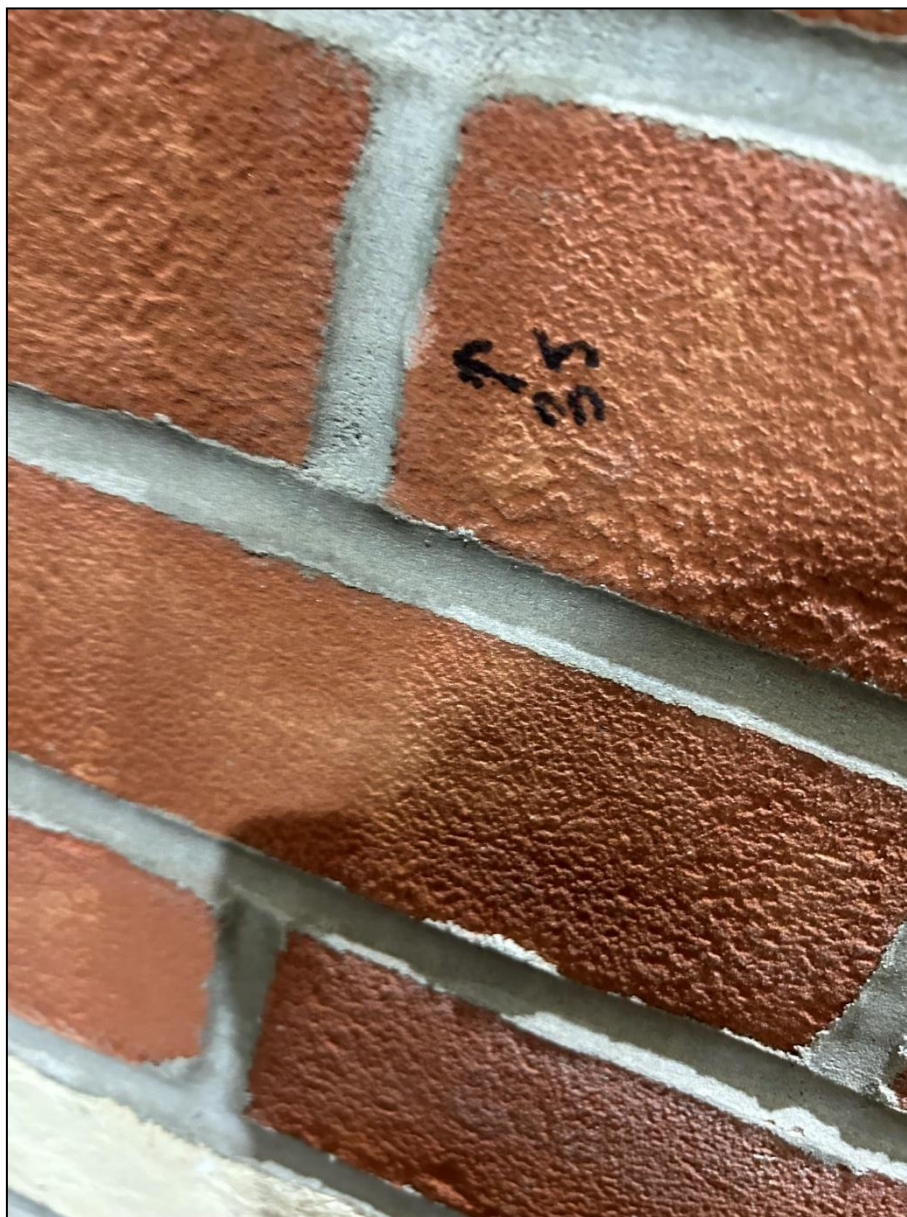
PHOTO IMG\_6160

| Location | Impact energy (J) | Observations | Classification |
|---|---|---|---|
| 41 | 3 | Small mark | Class 1 |

IMPACT LOCATION 41

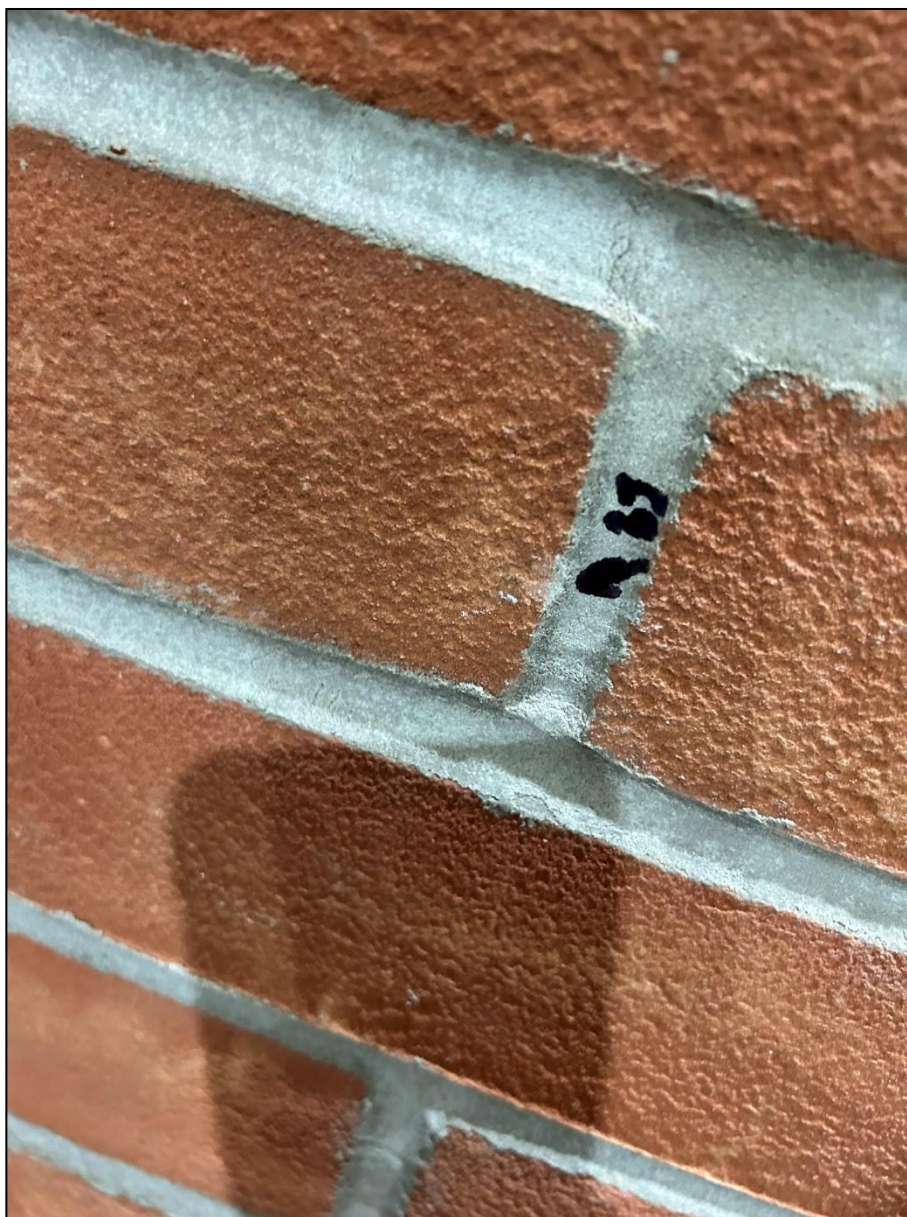
PHOTO IMG\_6161

| 42 | 3 | Small mark | Class 1<br>Negligible risk |

IMPACT LOCATION 42

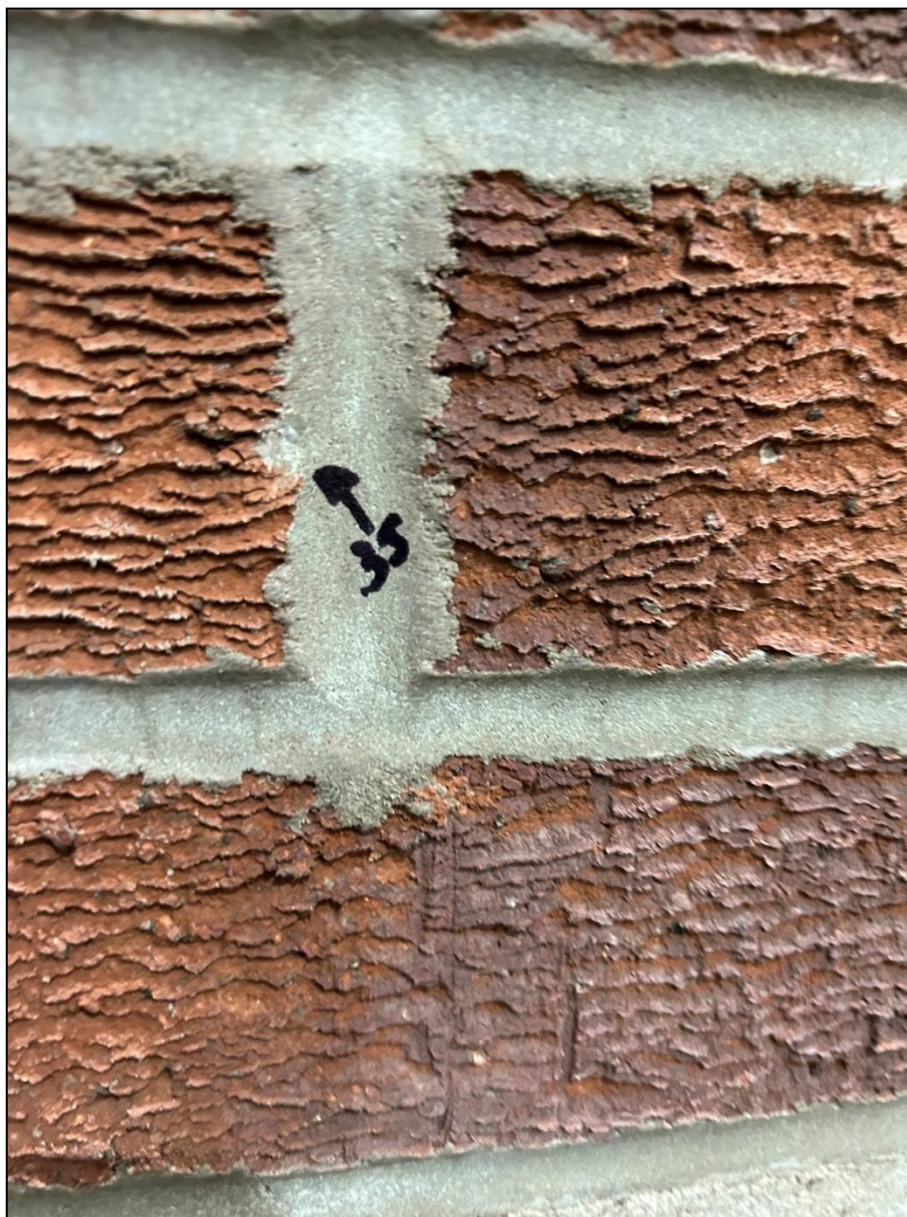
PHOTO IMG\_6162

| 43 | 3 | Small mark | Class 1<br>Negligible risk |

IMPACT LOCATION 43

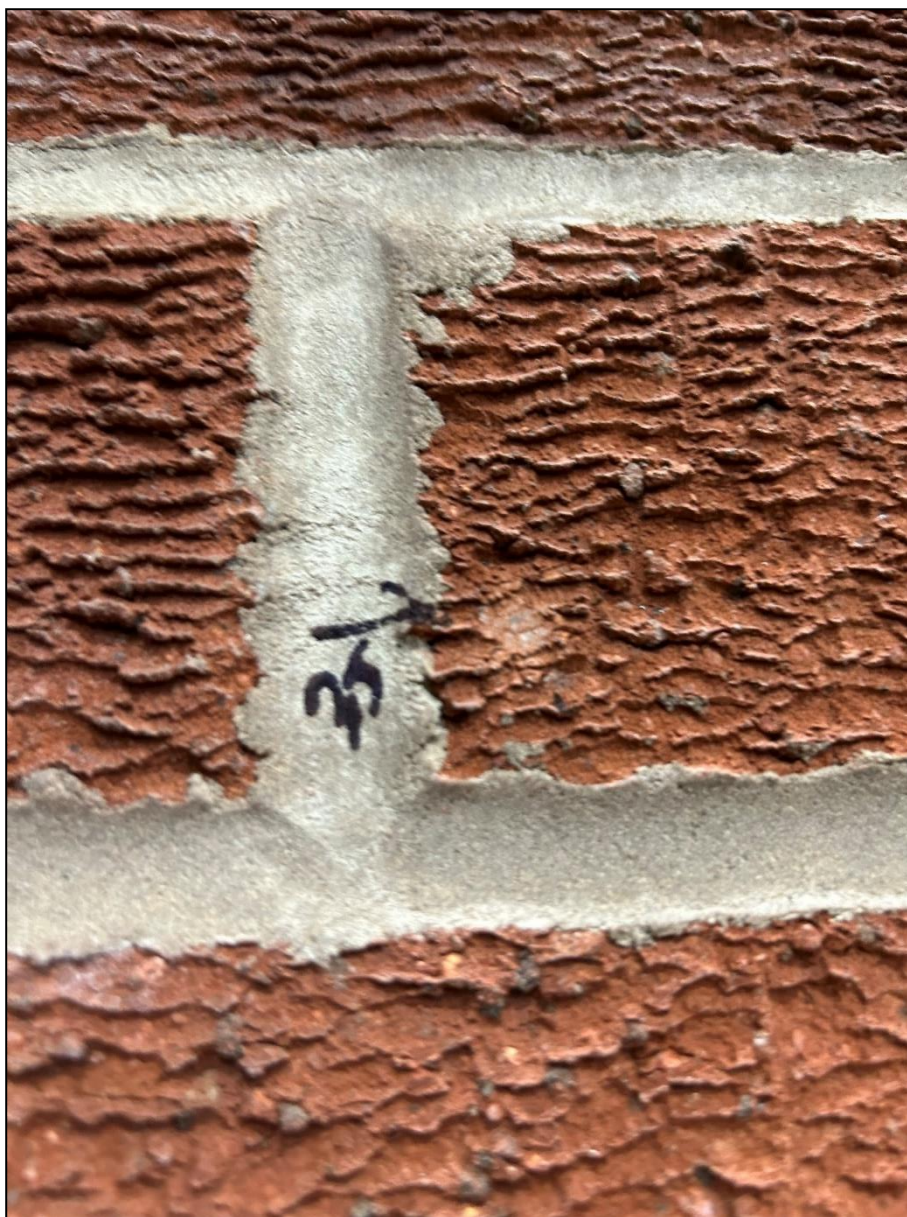
PHOTO IMG\_6163

| 44 | 3 | Small mark | Class 1<br>Negligible risk |

IMPACT LOCATION 44

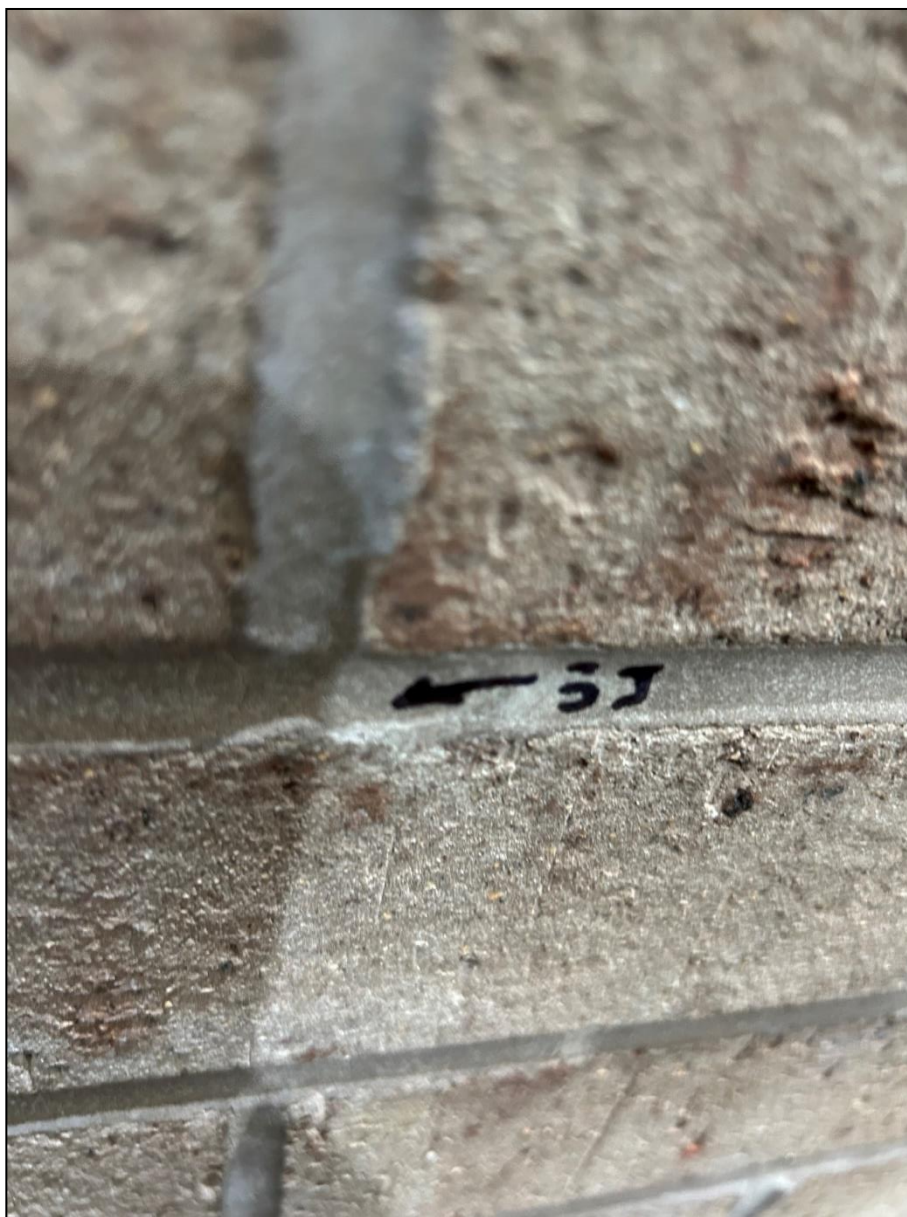
PHOTO IMG\_6164

| 45 | 3 | Small mark | Class 1<br>Negligible risk |

IMPACT LOCATION 45

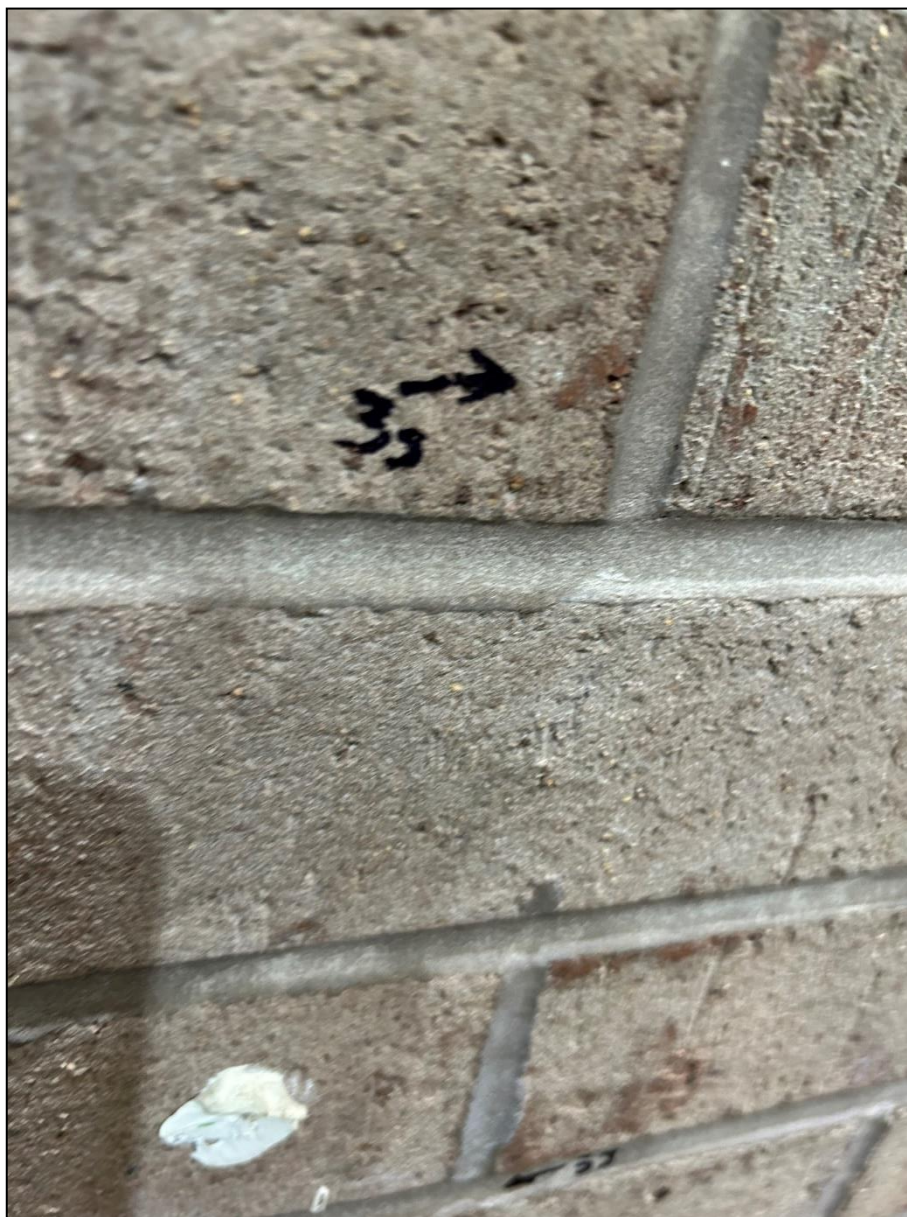
PHOTO IMG\_6165

| 46 | 3 | Small mark | Class 1<br>Negligible risk |

IMPACT LOCATION 46

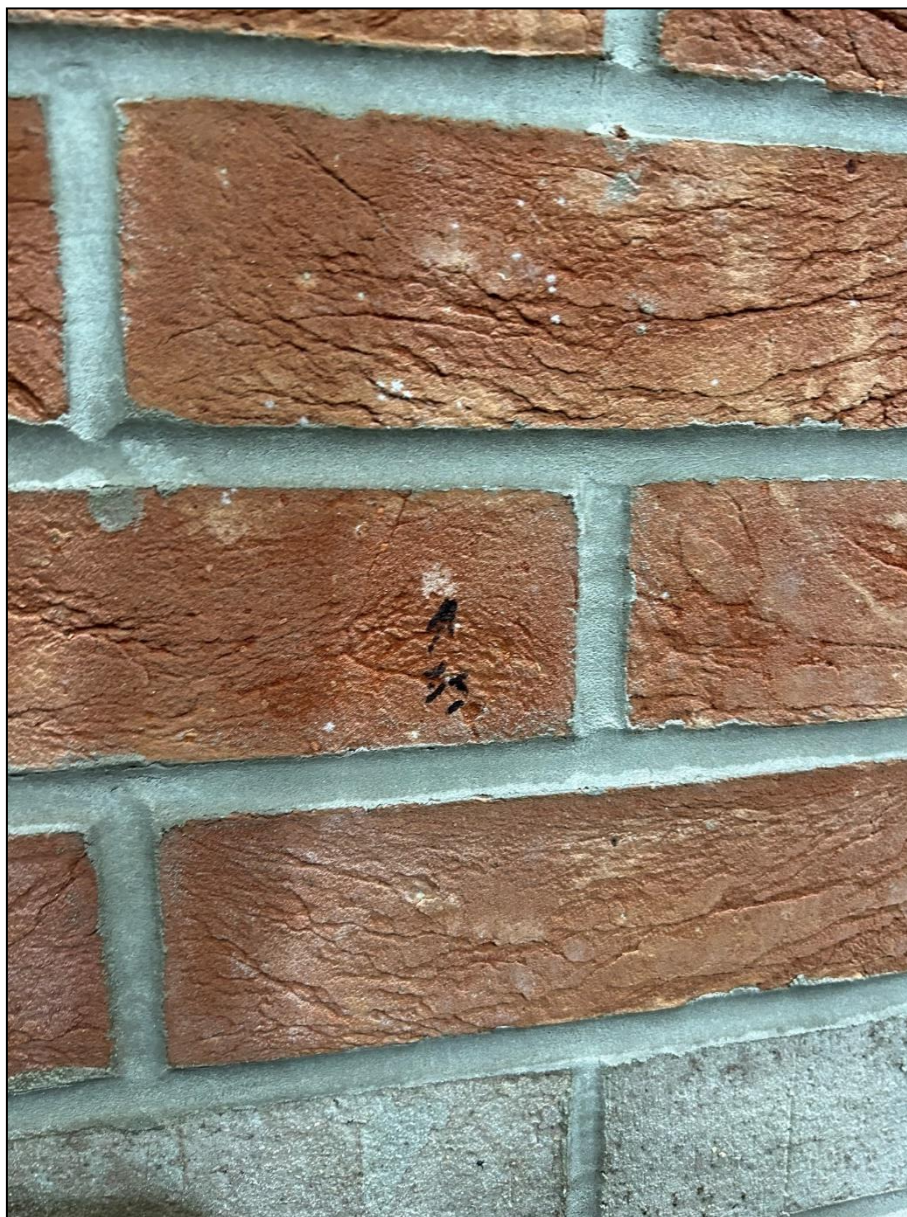
PHOTO IMG\_6166

| 47 | 3 | Small mark | Class 1<br>Negligible risk |

IMPACT LOCATION 47

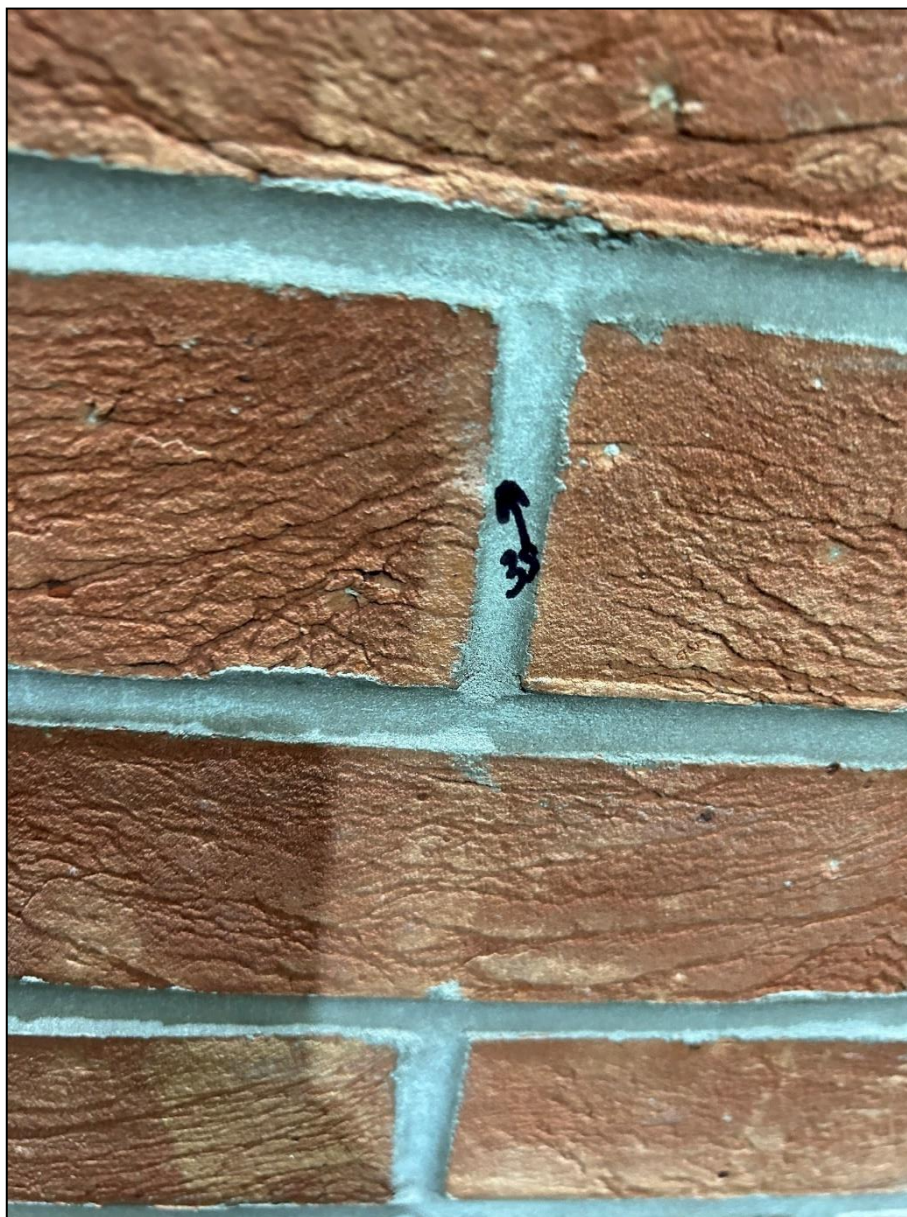
PHOTO IMG\_6167

| 48 | 3 | Small mark | Class 1<br>Negligible risk |

IMPACT LOCATION 48

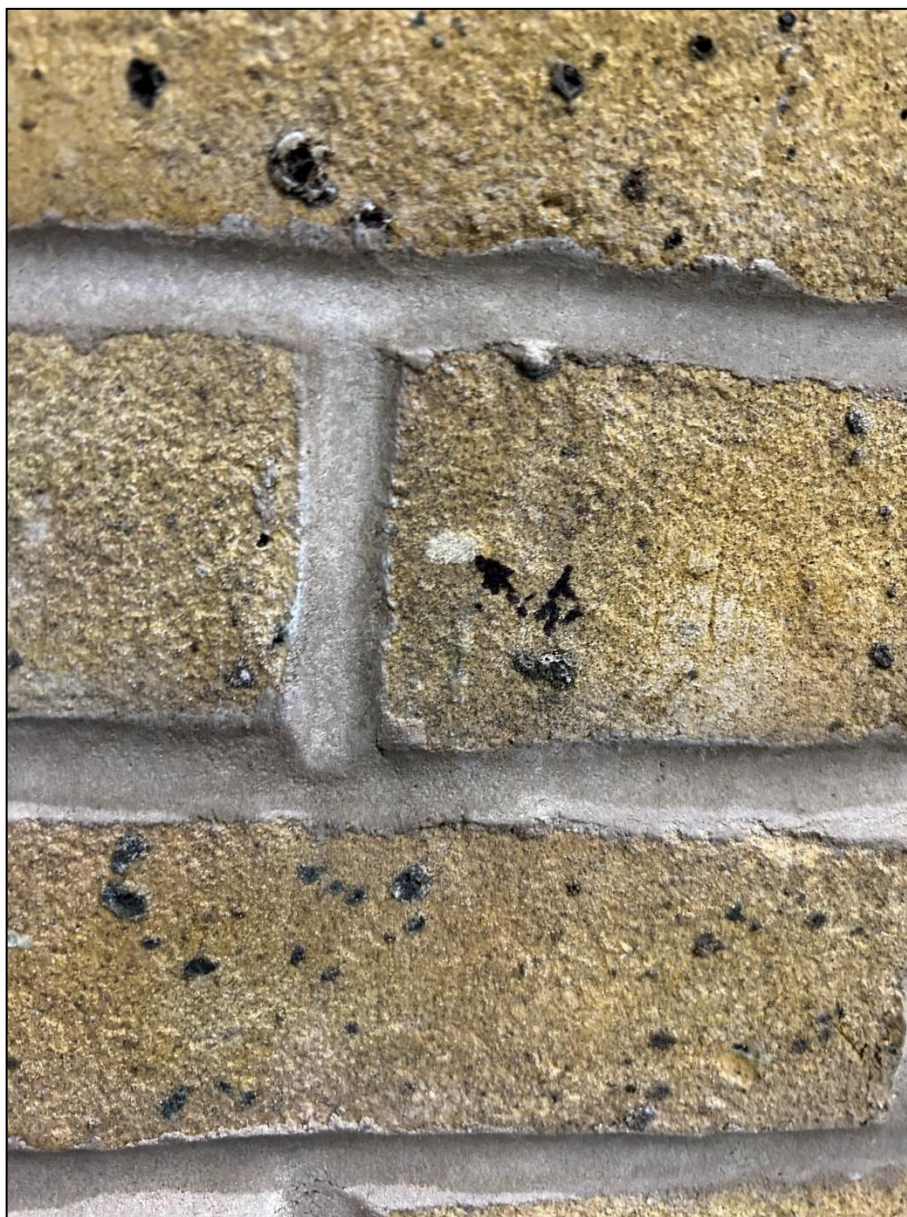
PHOTO IMG\_6168

| 49 | 3 | Small mark | Class 1<br>Negligible risk |

IMPACT LOCATION 49

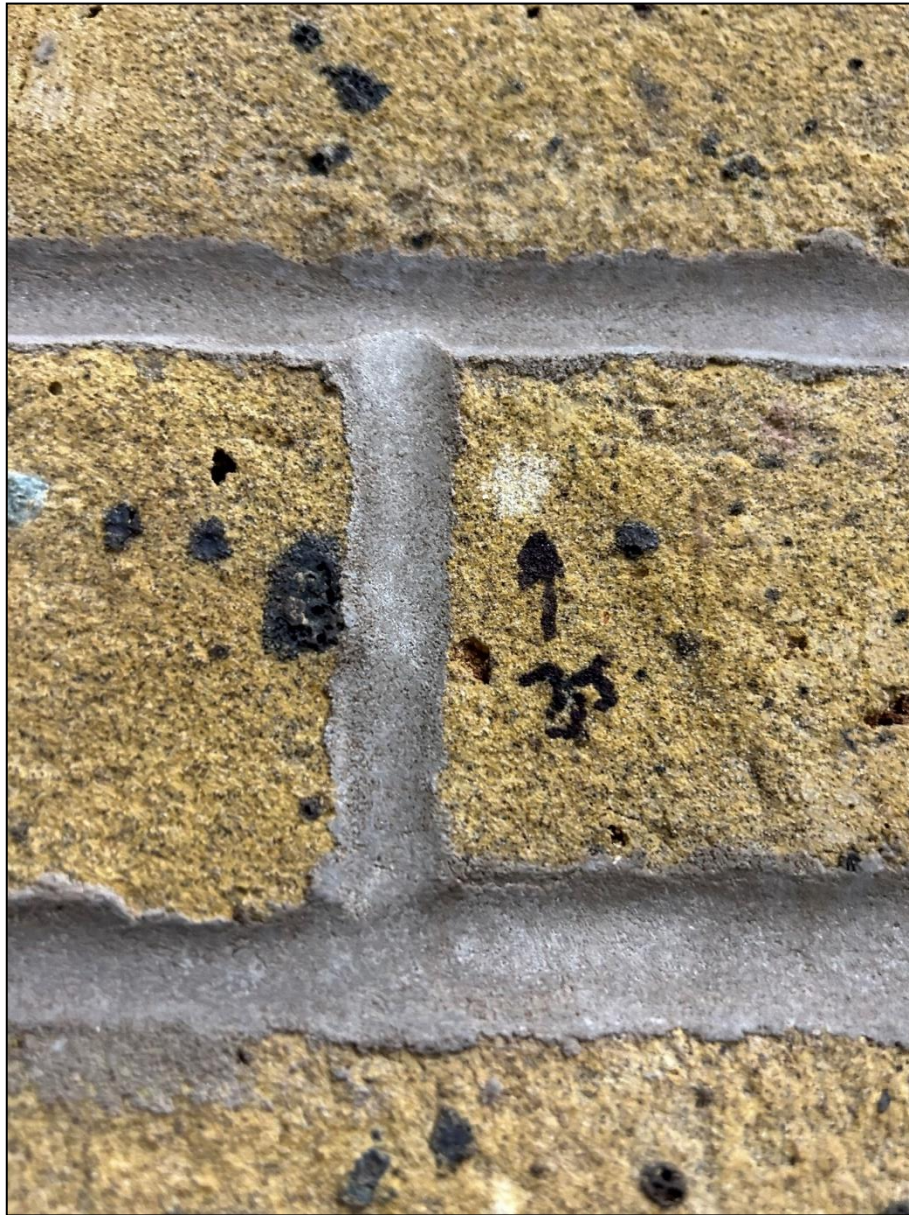
PHOTO IMG\_6169

| 50 | 3 | Small mark | Class 1<br>Negligible risk |

IMPACT LOCATION 50

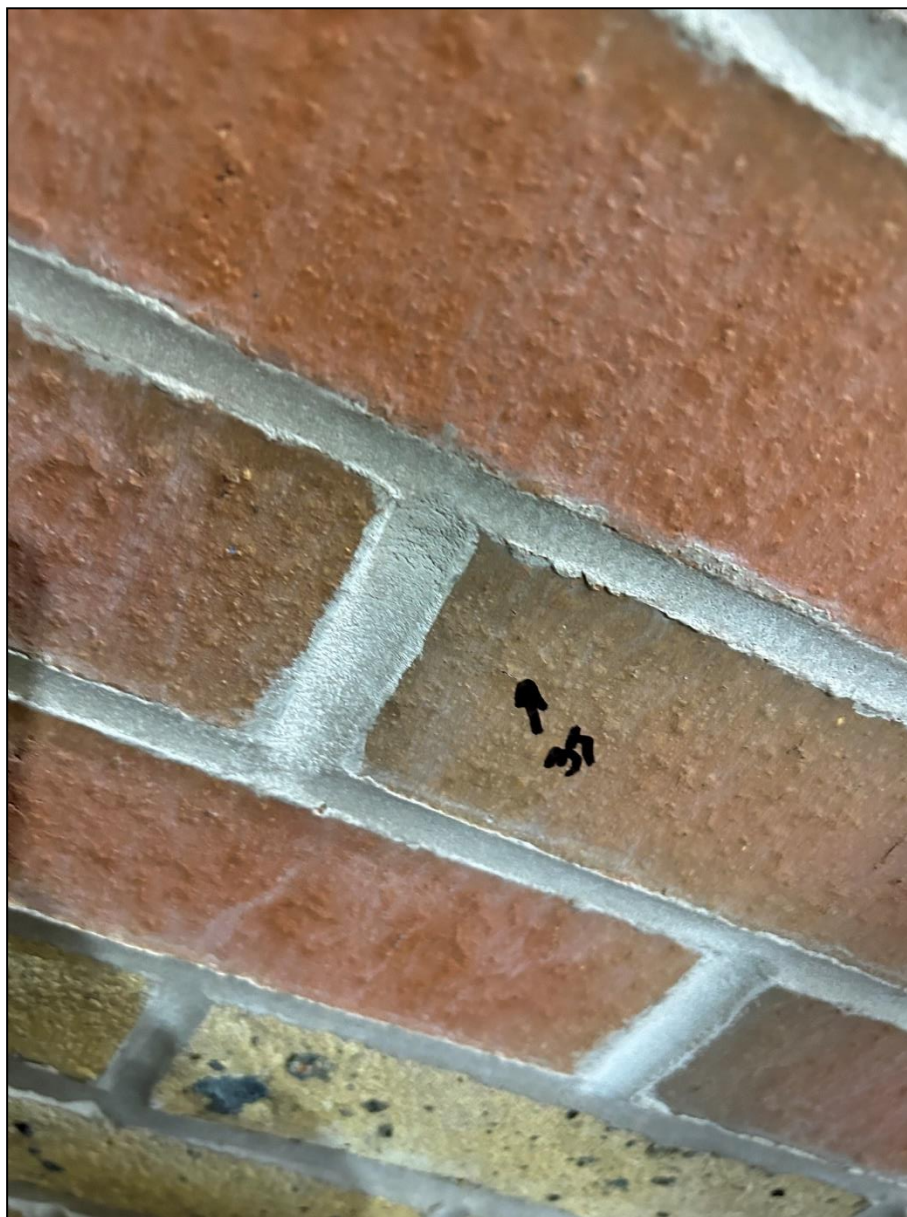
PHOTO IMG\_6170

| 51 | 3 | Small mark | Class 1<br>Negligible risk |

IMPACT LOCATION 51

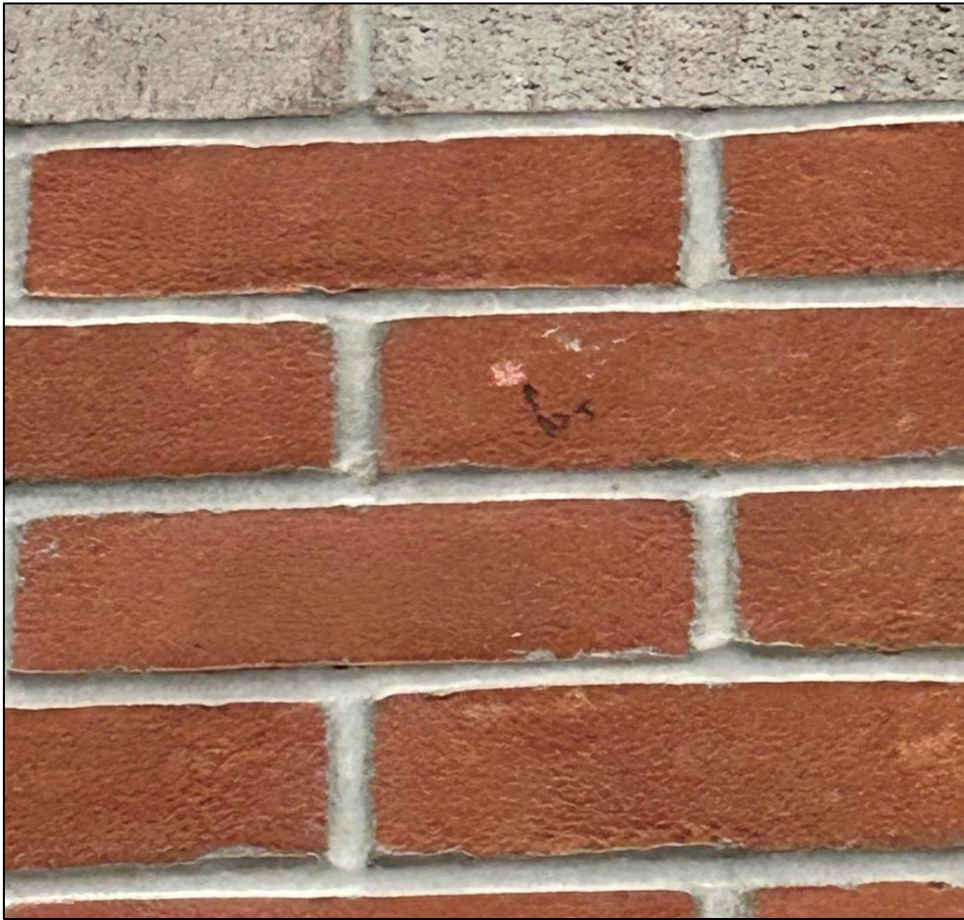
PHOTO IMG\_7239

| 108 | 10 | Small mark | Class 1<br>Negligible risk |

IMPACT LOCATION 108
