Title: Impact resistance testing of the Barracuda brick slip system

Report No: N950-22-18403

**Customer:** James & Taylor Ltd,  
Sixty-Two, Barwell Business Park,  
Leatherhead Road, Chessington, Surrey KT9 2NY.

**Issue date:** 7 February 2024

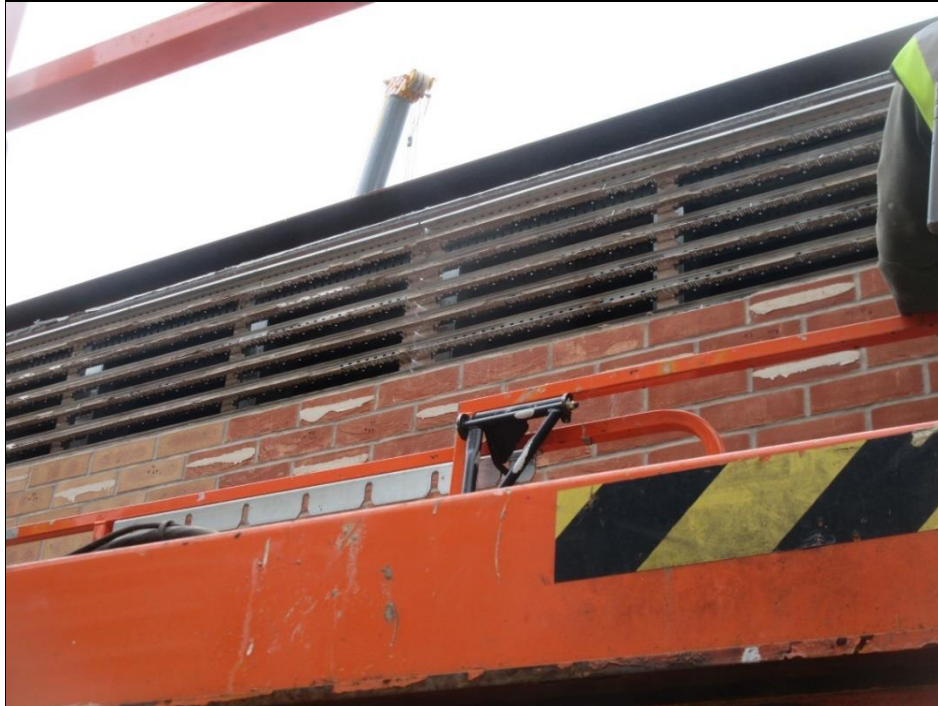
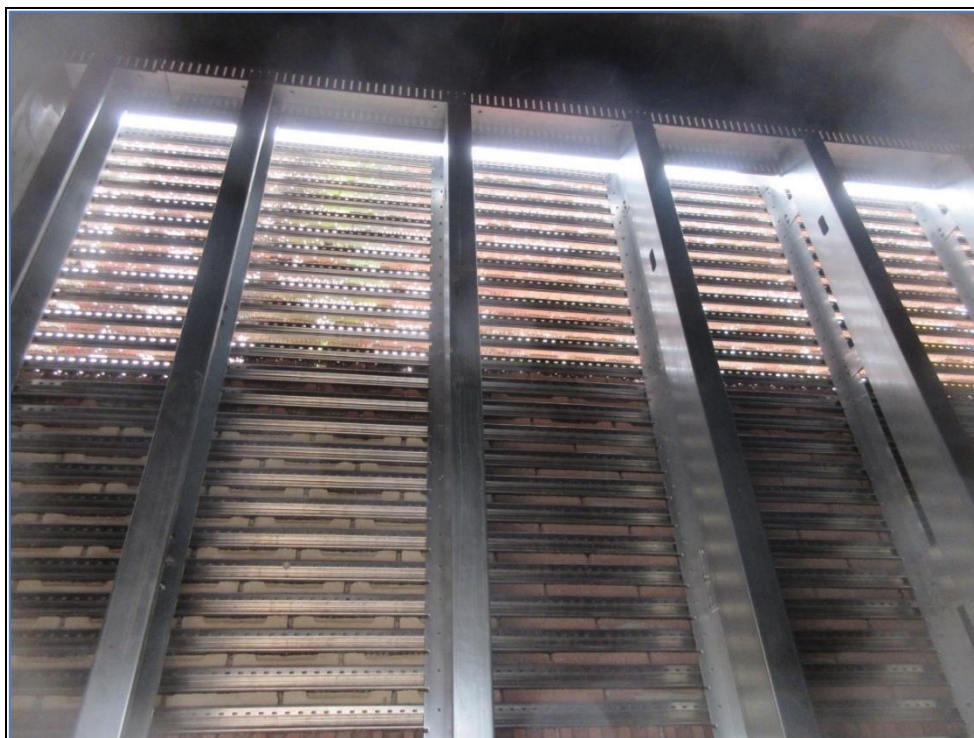
During the dismantling of the sample no discrepancies from the drawings were found.

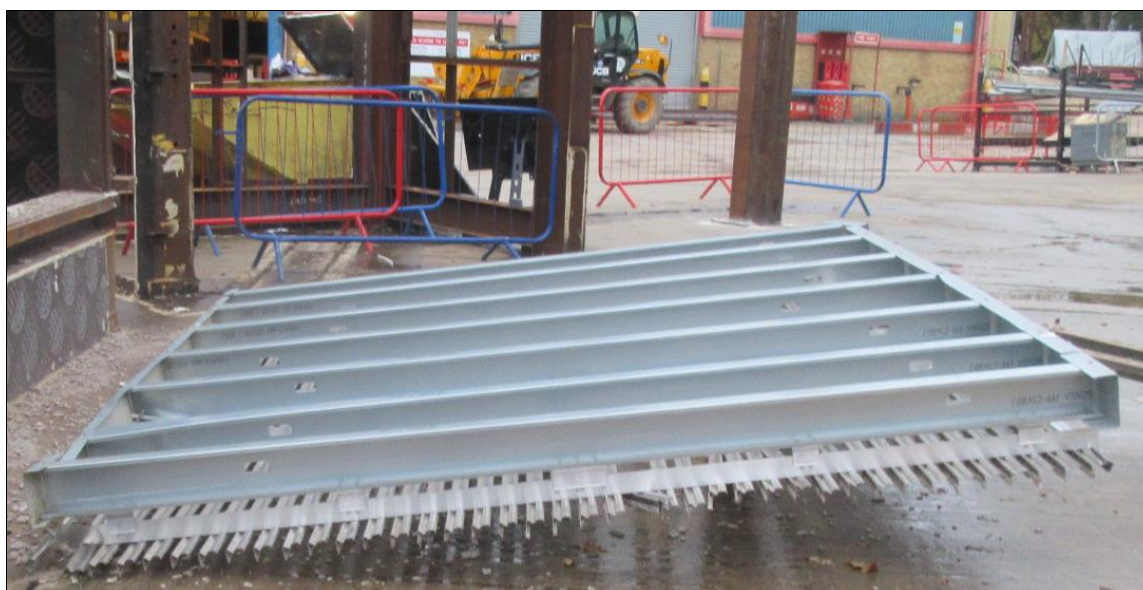
PHOTO 6181

SUPPORT FRAME REMOVED FROM TEST RIG
