Title: Impact resistance testing of the Barracuda brick slip system

Report No: N950-22-18403

**Customer:** James & Taylor Ltd,  
Sixty-Two, Barwell Business Park,  
Leatherhead Road, Chessington, Surrey KT9 2NY.

**Issue date:** 7 February 2024

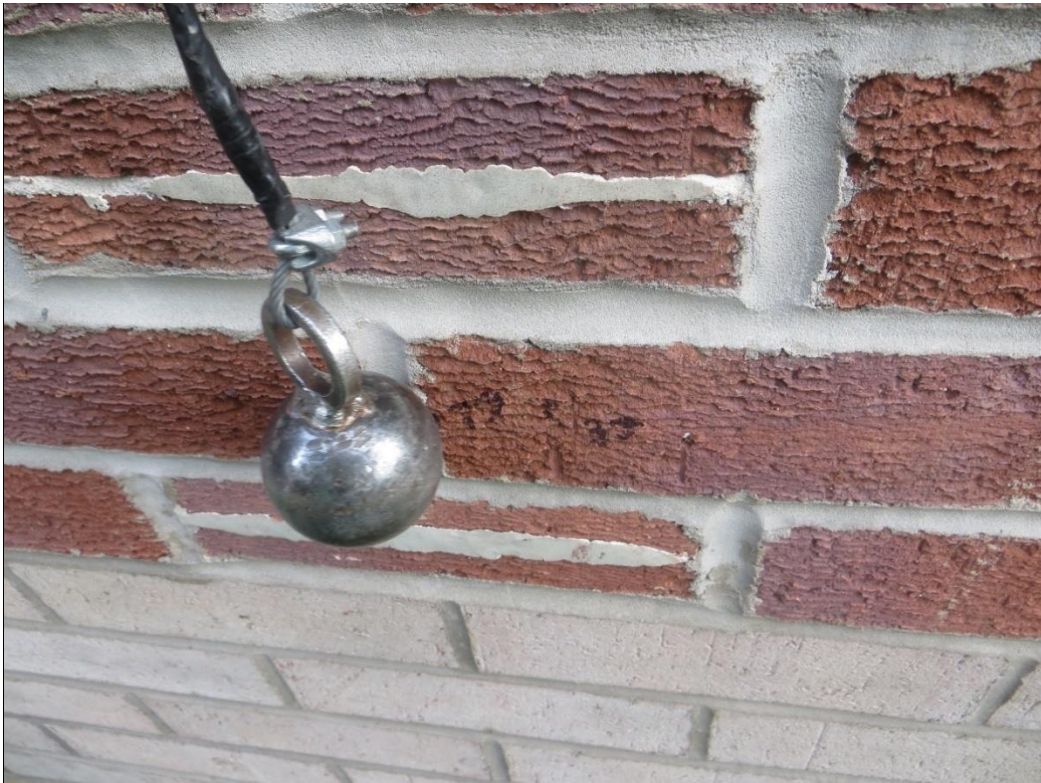
PHOTO 4041

3 J HARD BODY IMPACT

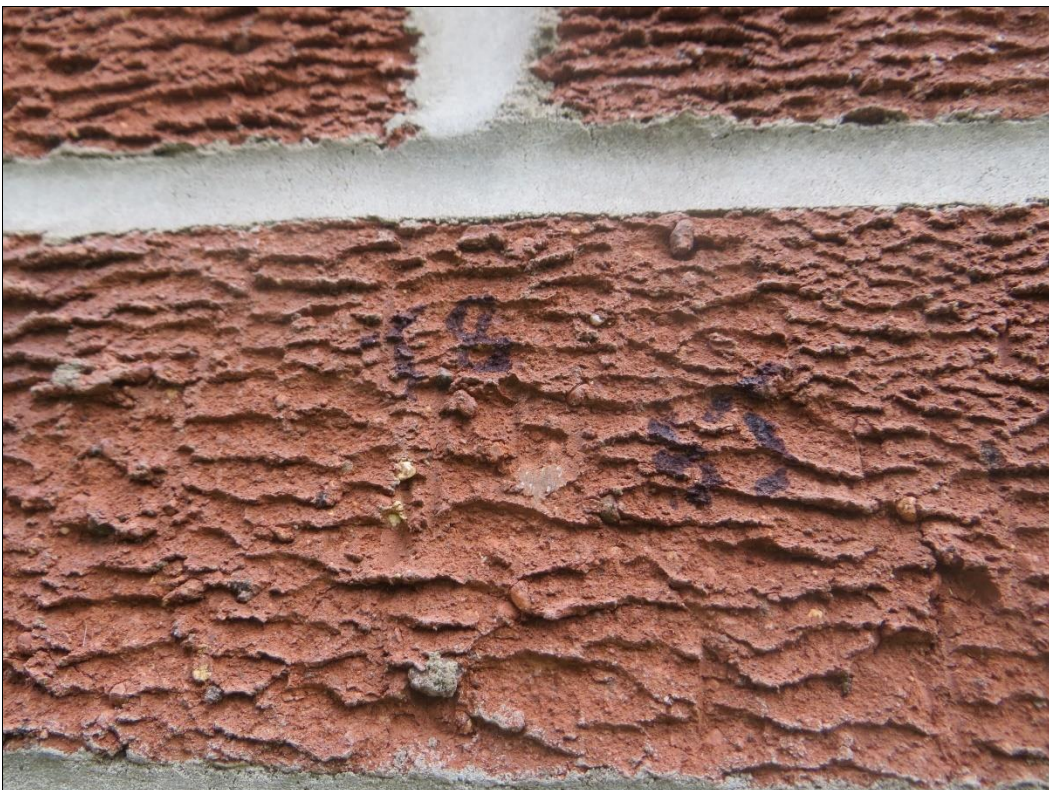
PHOTO 4030

6 J HARD BODY IMPACT

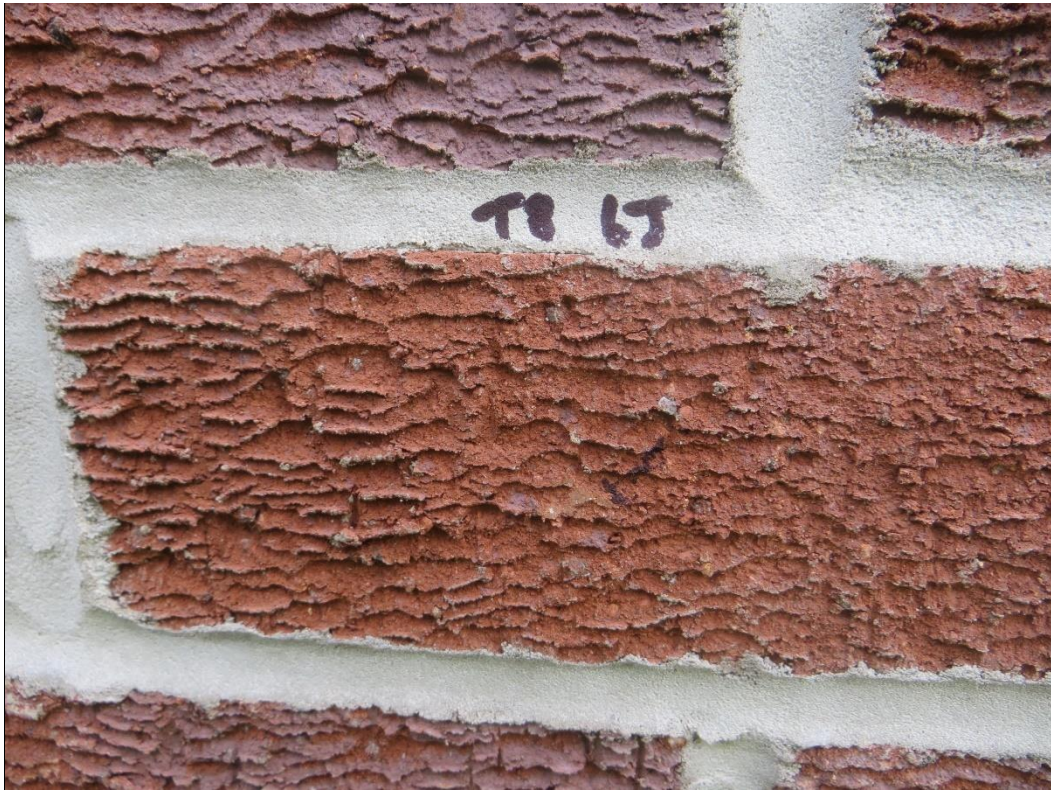
PHOTO 4031

6 J HARD BODY IMPACT

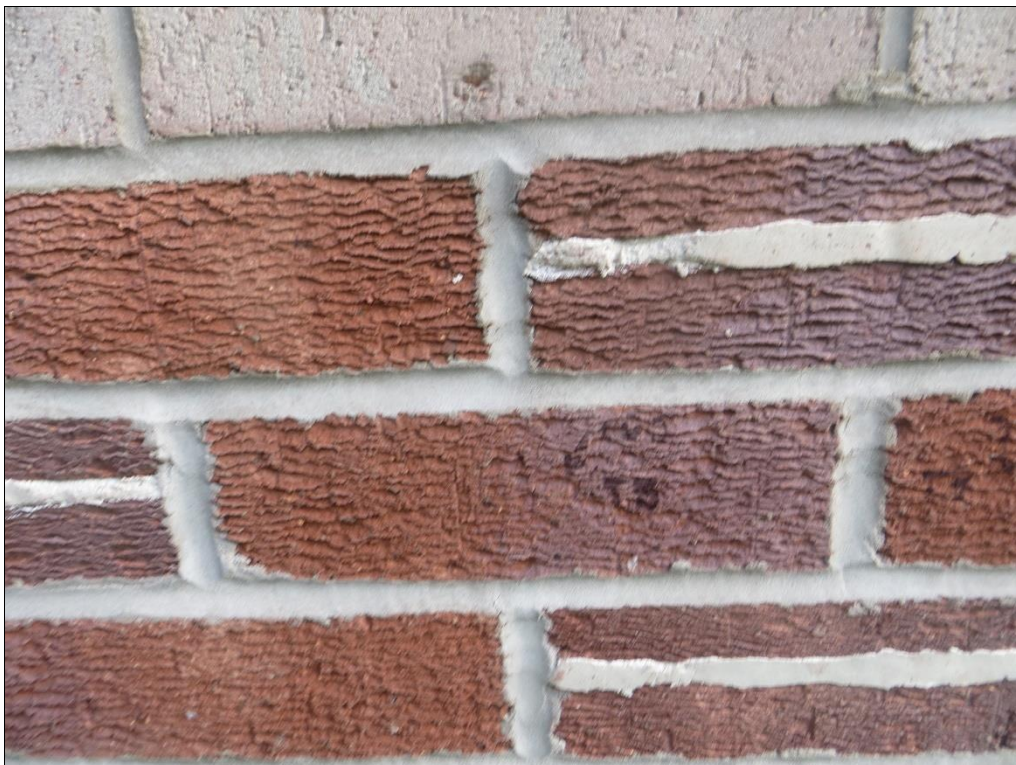
PHOTO 4063

10 J HARD BODY IMPACT

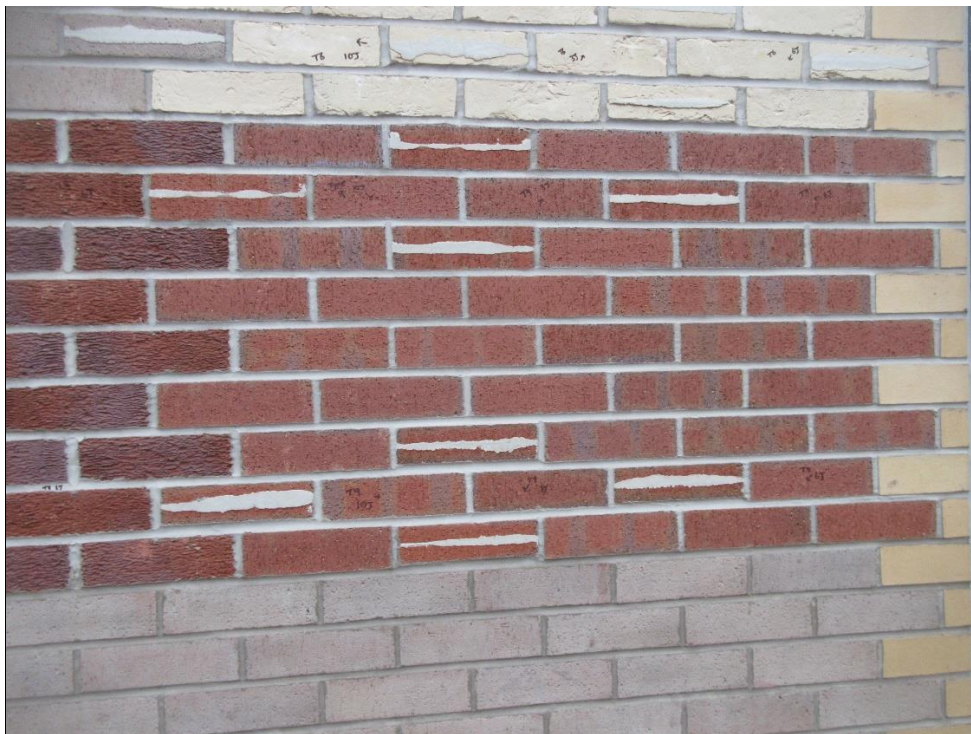
PHOTO 5713

| Location | Impact energy (J) | Observations | Classification |
|---|---|---|---|
| Upper left | 120 x 3 | No visible damage | Class 1 |
| Upper right | 350 | No visible damage | Negligible risk |
| Upper centre | 500 | No visible damage | Negligible risk |
| Lower left | 120 x 3 | No visible damage | Class 1 |
| Lower right | 350 | No visible damage | Negligible risk |
| Lower centre | 500 | No visible damage | Negligible risk |

### BRICK TYPE 9 AFTER IMPACT TESTS

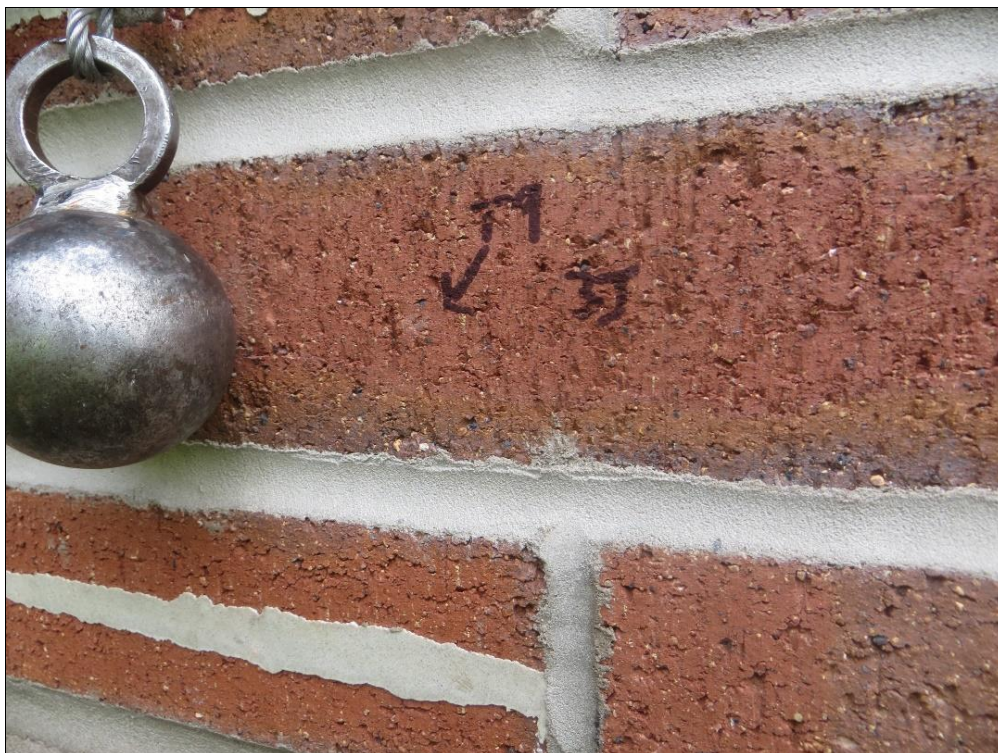
PHOTO 4018

### 3 J HARD BODY IMPACT

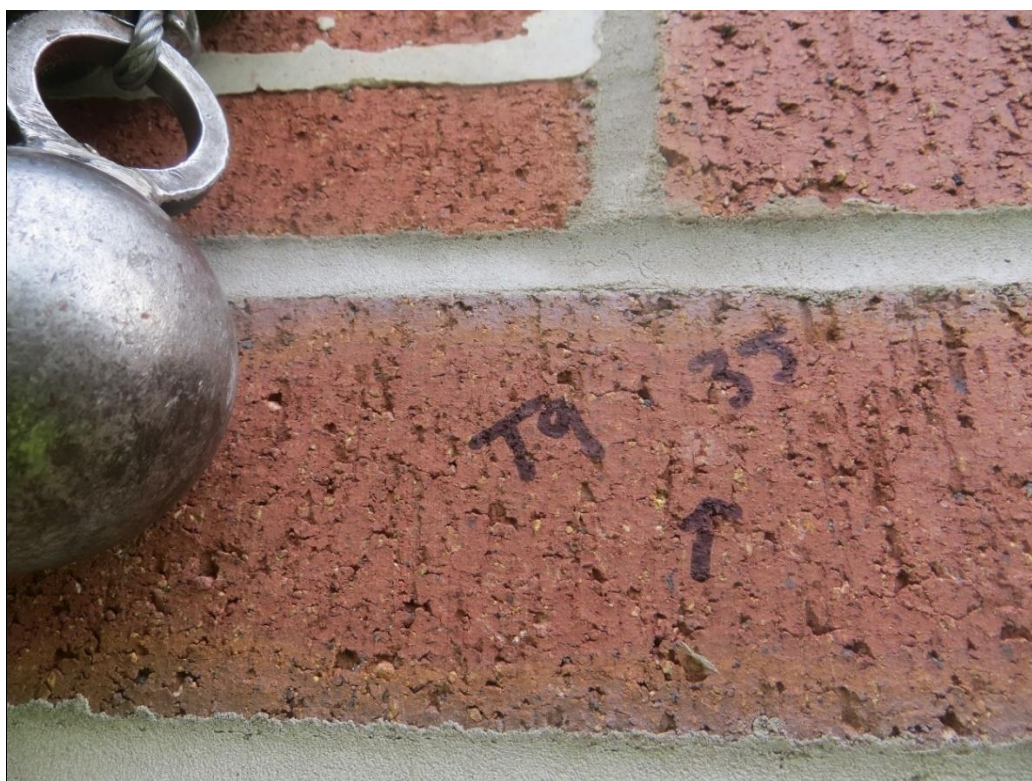
PHOTO 4029

3 J HARD BODY IMPACT

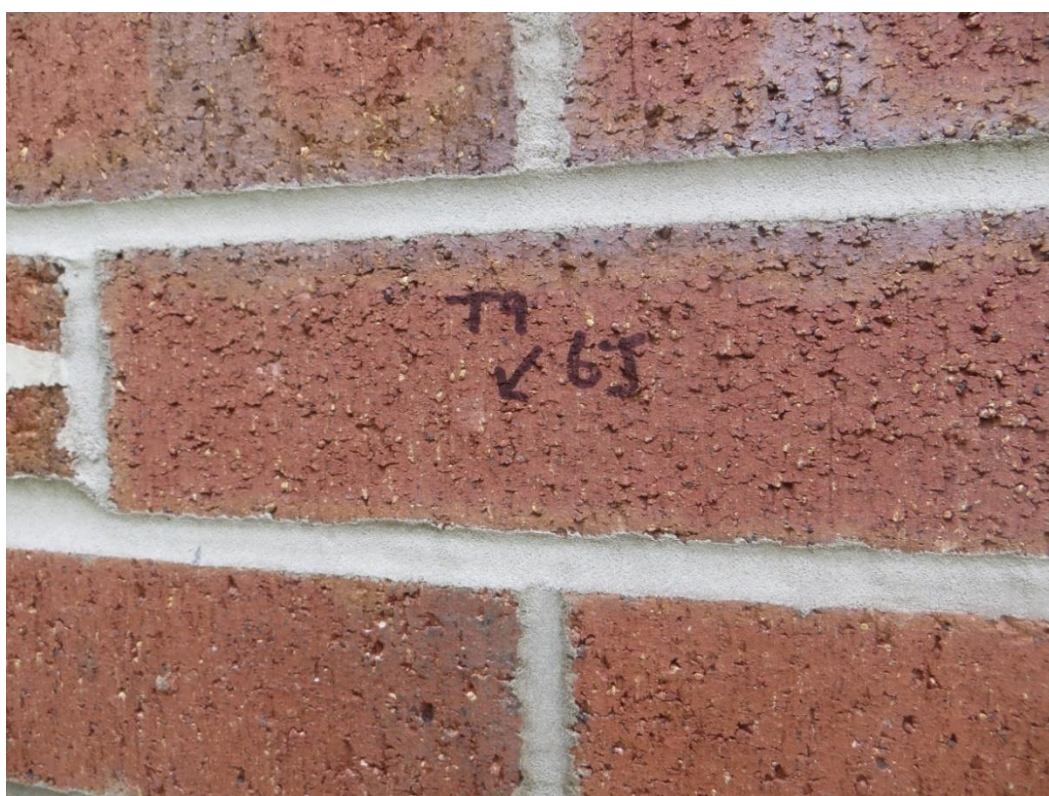
PHOTO 4019

6 J HARD BODY IMPACT

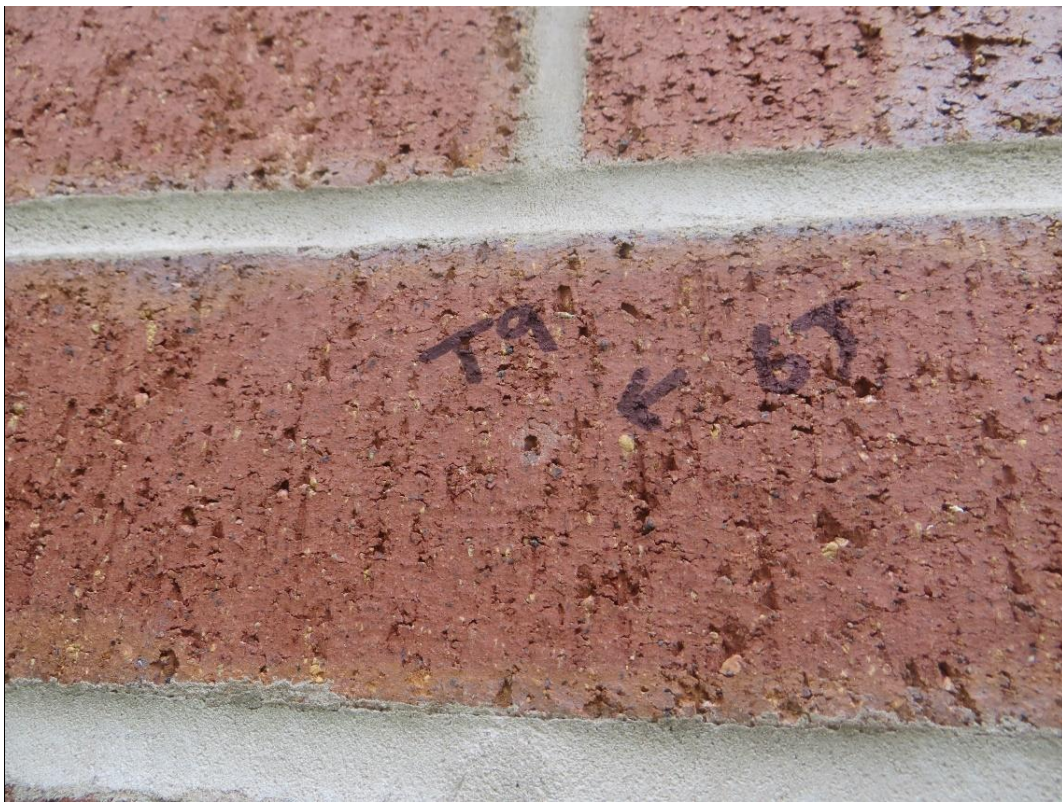
PHOTO 4020

6 J HARD BODY IMPACT

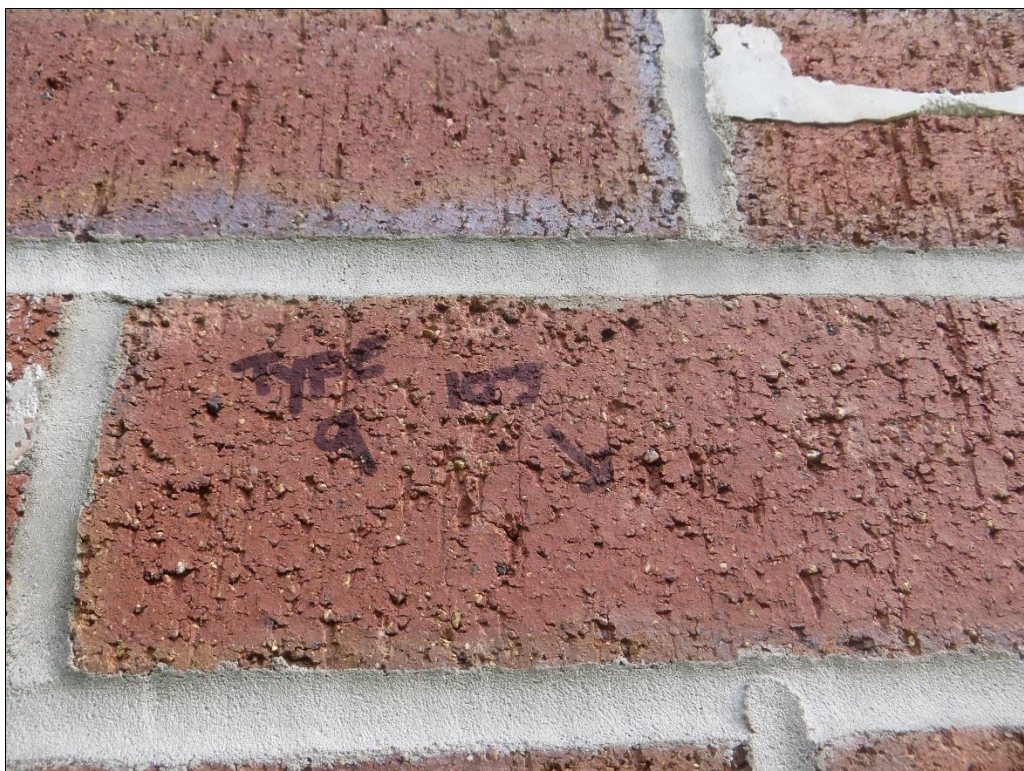
PHOTO 4071

10 J HARD BODY IMPACT

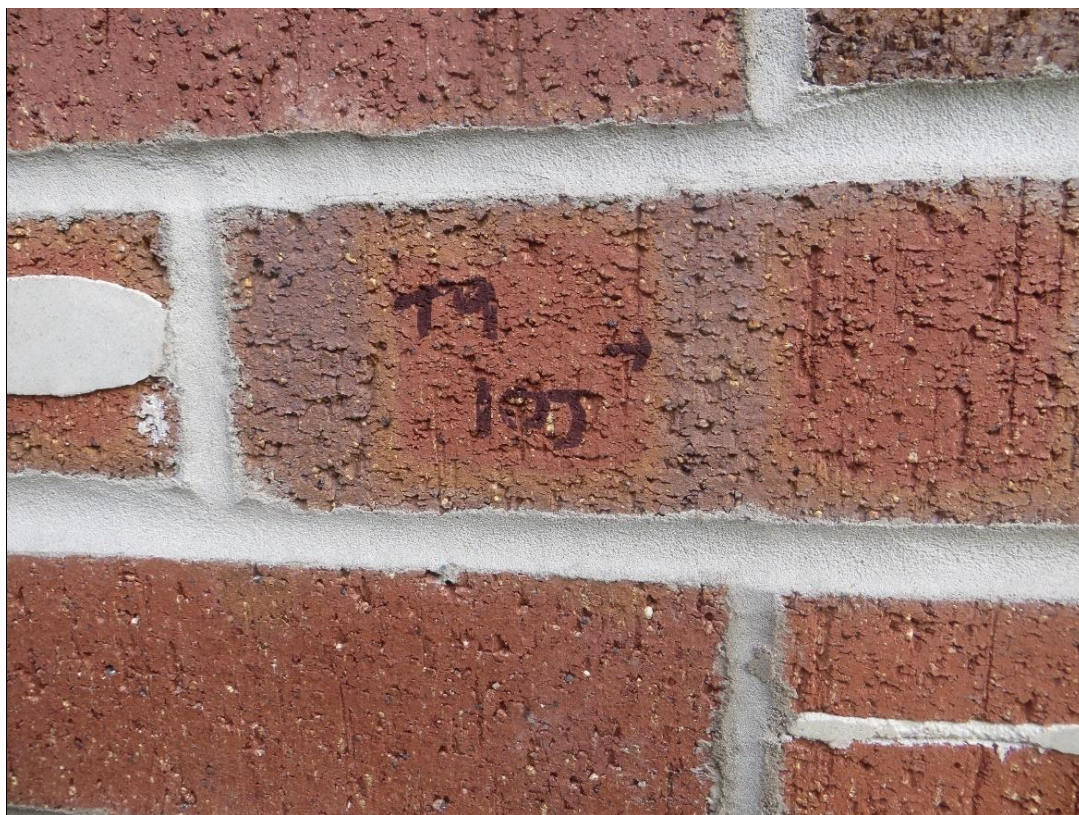
PHOTO 4072

10 J HARD BODY IMPACT

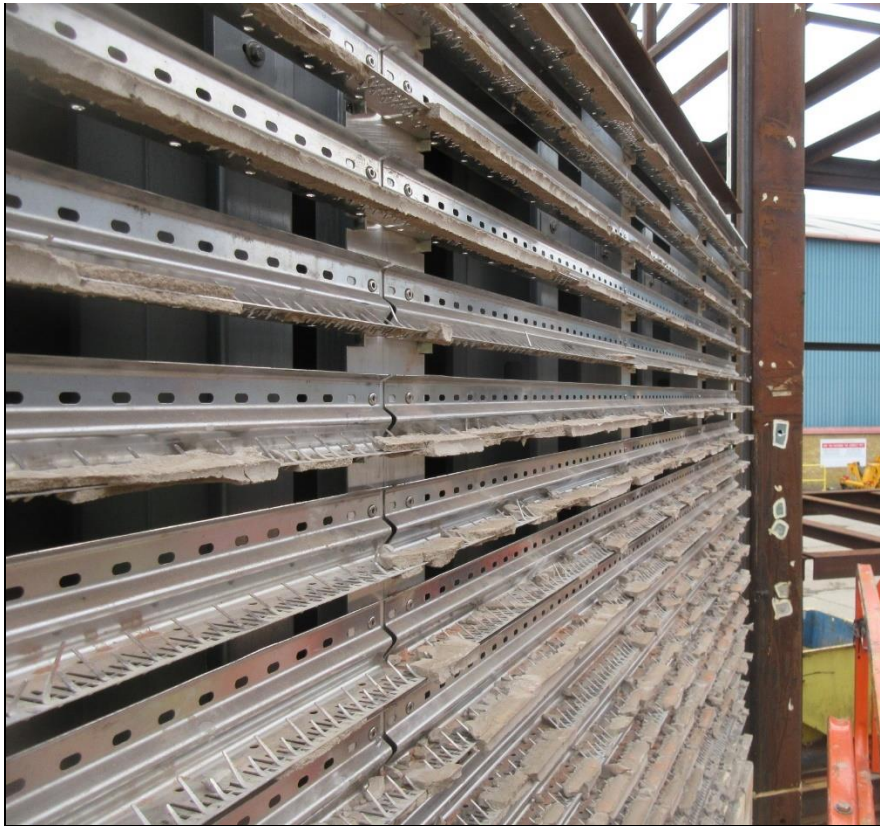
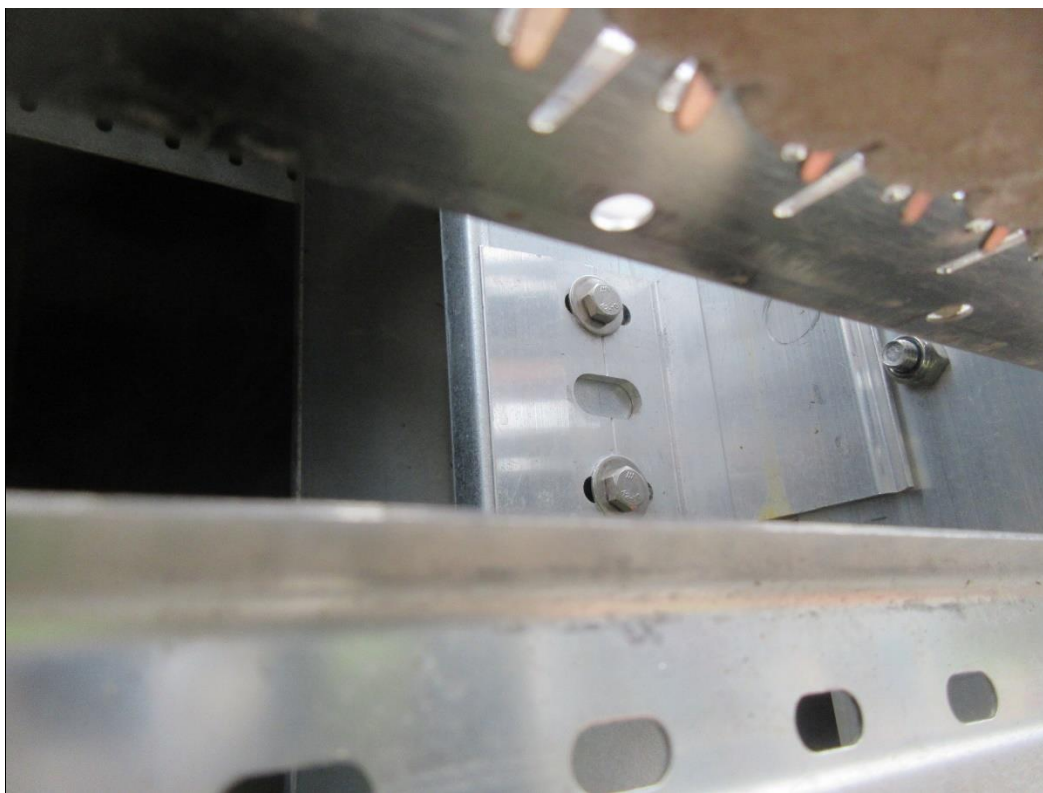
During the dismantling of the sample no discrepancies from the drawings were found.

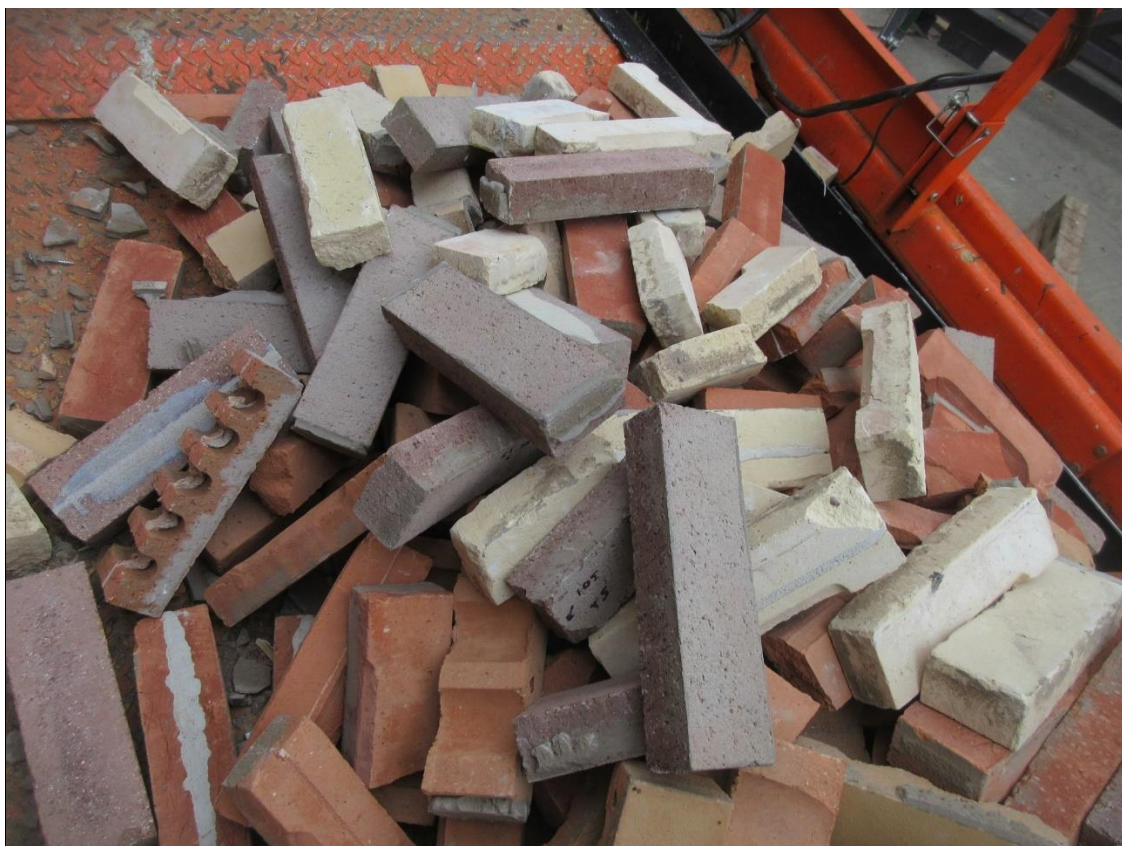
PHOTO 6160

BRICK SLIPS REMOVED FROM TEST RIG
